AIRPROX REPORT No 2023218

Date: 13 Sep 2023 Time: 1307Z Position: 5318N 00248W Location: 3NM SSE Liverpool

PART A: SUMMARY OF INFORMATION REPORTED TO UKAB

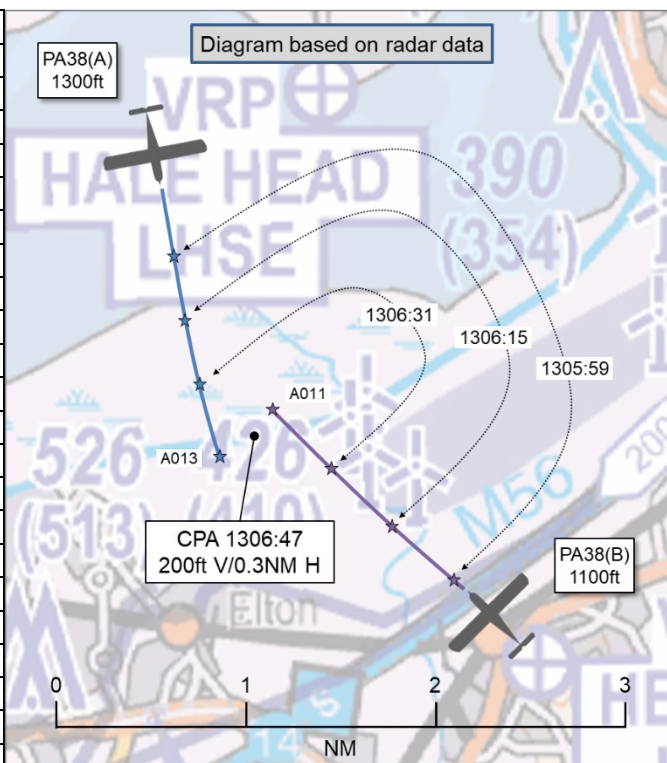
| Recorded | Aircraft 1 | Aircraft 2 |
|---|---|---|
| Recorded | 200ft V/0.3NM H | |

THE PA38(A) PILOT reports that, on departure with a student from RW09, they turned right to track to the standard outbound VRP at Taporely Roundabout. They were advised by ATC that there was a similar type aircraft inbound from the reciprocal direction at a similar altitude. [Both the pilot and student] began looking. They spotted the aircraft nose-on with a small profile. They advised ATC that they could see an aircraft in their 11 o'clock, similar altitude, possibly slightly lower, and asked if that was the correct traffic. They got an answer in the affirmative. They then assessed that the other traffic (that they ascertained had been [PA38(B)] by listening out to the ATC conversation) was not changing aspect much but was increasing in size. At one point they got a TA warning from their [EC device], so they took over the controls and climbed slightly to be more visible to the other aircraft. They turned more to the right and started to rock their wings to increase visibility as the other pilot did not seem to notice the closing aspect. They passed by [PA38(B)] and continued with their flight, but advised the company operational team about the Airprox and noted the time.
