AIRPROX REPORT No 2023233

Date: 03 Oct 2023 Time: 1135Z Position: 5418N 00115W Location: 4NM NNE Sutton Bank

PART A: SUMMARY OF INFORMATION REPORTED TO UKAB

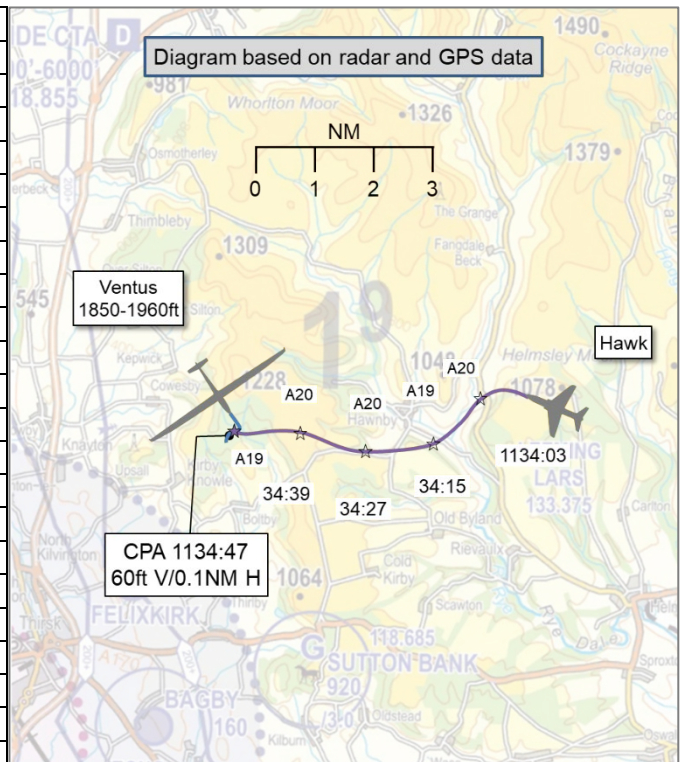
THE VENTUS PILOT reports flying up and down the ridge to the west of Sutton Bank gliding site in a 15kt westerly wind, heading north/south up to five miles from the gliding site. At a point 5 miles north of the gliding site, and as they were circling, they saw a Hawk jet which passed to the north of them at about the same level. It rolled and descended to below the ridge height heading towards the west.

THE HAWK PILOT reports returning to RAF Leeming from a Low-Level Introduction sortie when a glider was observed. To telegraph that the glider had been observed, a descent of about 500ft was made to pass below and to the right of the glider. Following in-brief after the sortie it was reported that the glider pilot had reported an Airprox.

THE LEEMING CONTROLLER AND SUPERVISOR reports they did not observe the Airprox on radar. The radar replay showed a fast-jet [the Airprox Hawk] exit low-level to the northeast of Sutton Bank by 5NM and track west at about 2000ft. As it did so, the Hawk dropped 500ft in one sweep when about 5NM north of Sutton Bank. No Airprox was reported on any Leeming frequency.

The Airprox is believed to have occurred prior to the Hawk pilot exiting the low-level system and contacting Leeming ATC for recovery because the 500ft descent reported by the Hawk was observed as the Hawk exited to the northeast of Sutton Bank.
