AIRPROX REPORT No 2023236

Date: 07 Oct 2023 Time: 1128Z Position: 5414N 00113W Location: Sutton Bank

PART A: SUMMARY OF INFORMATION REPORTED TO UKAB

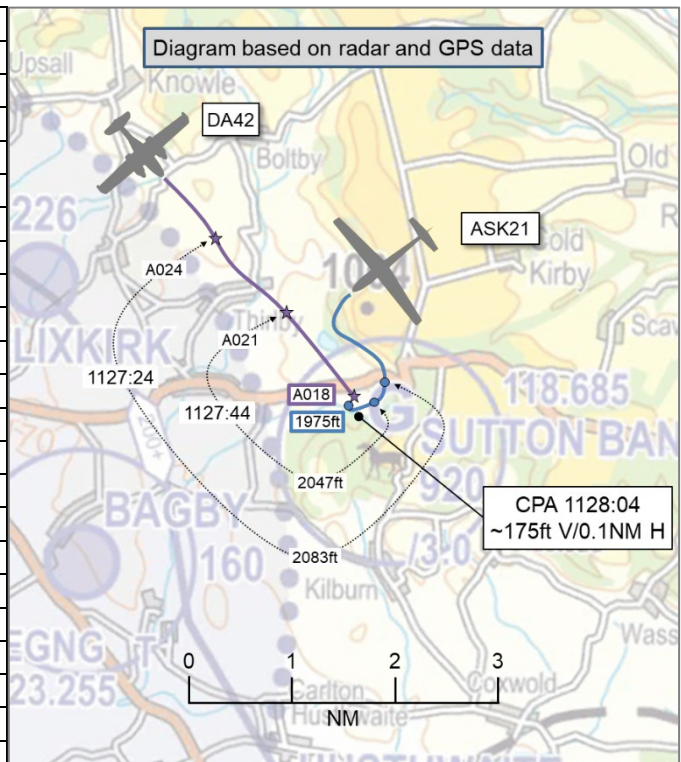
Recorded	Aircraft 1	Aircraft 2
Aircraft	ASK21	DA42
Operator	Civ Gld	Civ FW
Airspace	London FIR	London FIR
Class	G	G
Rules	VFR	VFR
Service	Listening Out	Basic
Provider	Sutton Bank Traffic	Teesside Radar
Altitude/FL	1975ft	1800ft
Transponder	Not fitted	A, C, S+
Reported		
Colours	White, red	White
Lighting	Nil	Strobes
Conditions	VMC	VMC
Visibility	5-10km	5-10km
Altitude/FL	900ft	2000ft
Altimeter	QFE (989hPa)	QNH
Heading	300°	NK
Speed	50kt	140kt
ACAS/TAS	FLARM	Not fitted
Alert	None	N/A
Separation at CPA		
Reported	100ft V/0m H	50ft V/0.25NM H
Recorded	~175ft V/0.1NM H
