AIRPROX REPORT No 2023258

Date: 25 Nov 2023 Time: 1359Z Position: 5329N 00253W Location: 1NM north of KIRKBY VRP

PART A: SUMMARY OF INFORMATION REPORTED TO UKAB

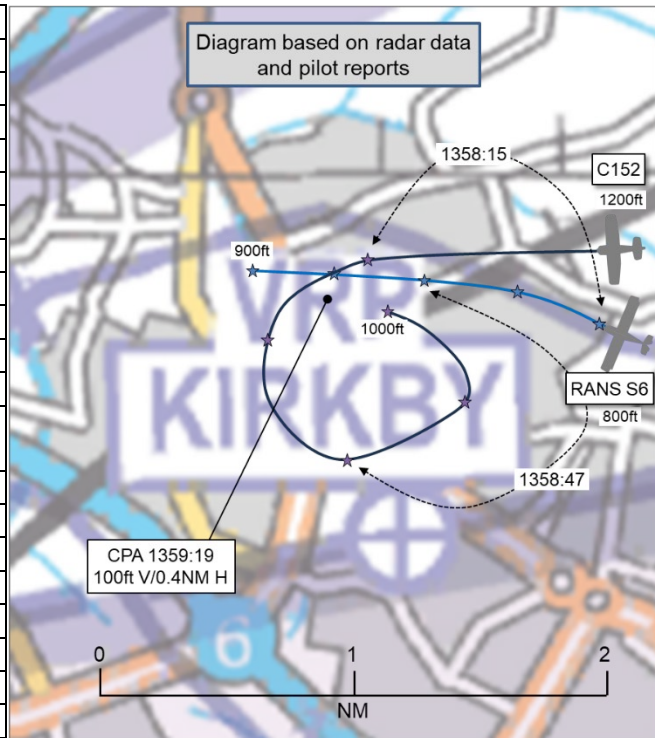
Recorded	Aircraft 1	Aircraft 2
Aircraft	RANS S6	C152
Operator	Civ FW	Civ Comm
Airspace	London FIR	London FIR
Class	G	G
Rules	VFR	VFR
Service	None	Basic
Provider	N/A	Liverpool Radar
Altitude/FL	900ft	1000ft
Transponder	A, C, S	A, C, S
Reported		
Colours	Blue	White/Red
Lighting	None	Beacon, navigation, landing
Conditions	VMC	VMC
Visibility	>10km	>10km
Altitude/FL	1000ft	1320ft AGL
Altimeter	QNH (1021hPa)	QNH (1026hPa)
Heading	270°	'Orbiting'
Speed	70kt	80kt
ACAS/TAS	SkyEcho	SkyEcho
Alert	Information	Information
Separation at CPA		
Reported	0ft V/<0.1NM H	500ft V/>1NM H
Recorded	100ft V/0.4NM H
