AIRPROX REPORT No 2023266

Date: 08 Dec 2023 Time: 1458Z Position: 5201N 00001W Location: 13NM NW Stansted

PART A: SUMMARY OF INFORMATION REPORTED TO UKAB

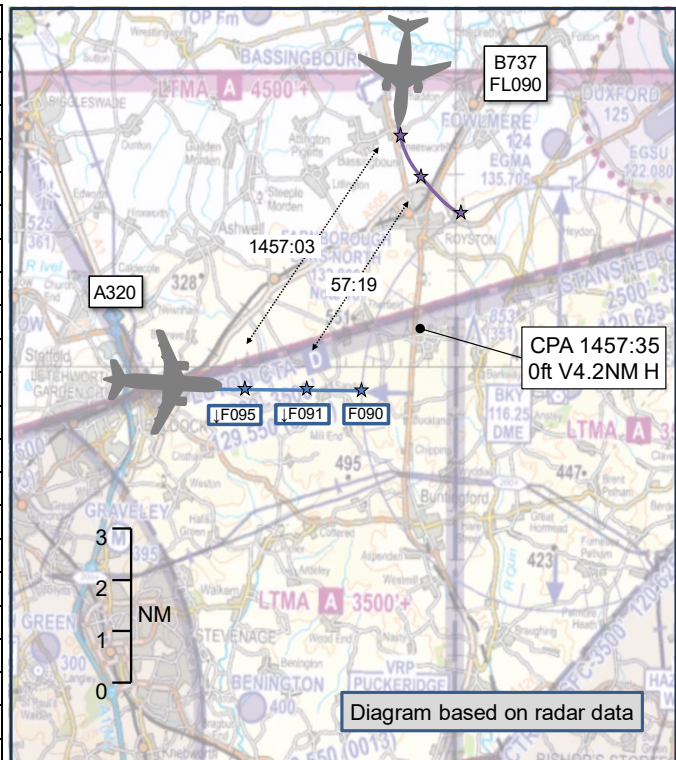
Recorded	Aircraft 1	Aircraft 2
Aircraft	A320	B737
Operator	CAT	CAT
Airspace	London TMA	London TMA
Class	A	A
Rules	IFR	IFR
Service	Radar Control	Radar Control
Provider	Swanwick NW	Swanwick SS INT
Altitude/FL	FL090	FL090
Transponder	A, C, S+	A, C, S+
Reported		
Colours	Company	Company
Lighting	NK	'Standard'
Conditions	NK	VMC
Visibility	NR	>10km
Altitude/FL	FL090	NK
Altimeter	SPS	QNH
Heading	NK	NK
Speed	NK	NK
ACAS/TAS	TCAS II	TCAS II
Alert	Information	None
Separation at CPA		
Reported	NR	Not Seen
Recorded	0ft V/4.2NM H
