**AIRPROX REPORT No 2024009**

Date: 18 Jan 2024 Time: 1435Z Position: 5220N 00120W Location: Draycote Water

**PART A: SUMMARY OF INFORMATION REPORTED TO UKAB**

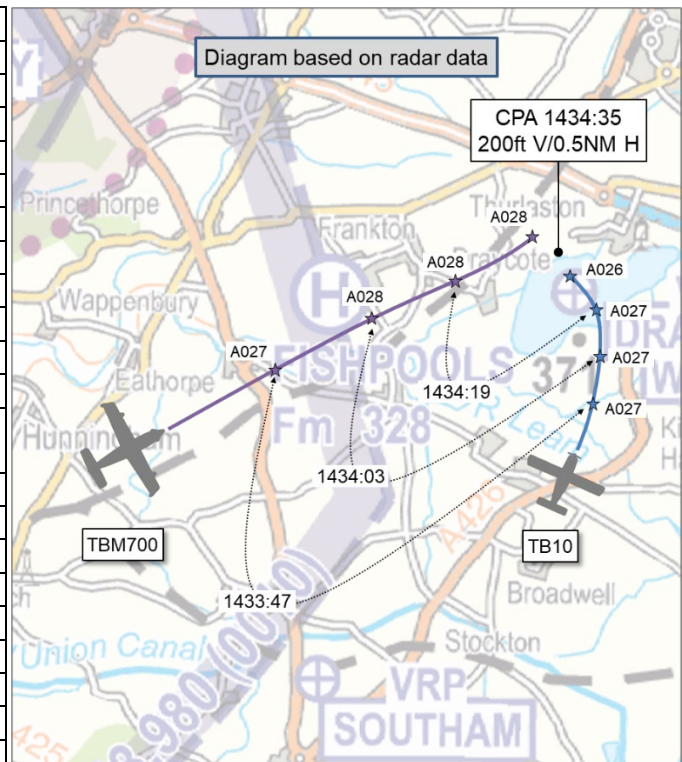
**THE TB10 PILOT** reports that, from crossing the M40, they had been under a Basic Service from Coventry Information, had reported that they were tracking to Draycote VRP and would call once overhead. The call was made overhead Draycote at 1800ft but, mid-transmission, a TBM flew close to their left-side from the rear and turned left, cutting in-front. Following that manoeuvre, the TBM seemed to be descending and then ascending to a point that [the TB10 pilot] thought it would be too high for Birmingham airspace.

At the point that the [pilot of the TBM] had cut in front, [the pilot of the TB10] made a right turn for separation which led them to cut into NOTAM'd airspace.
