AIRPROX REPORT No 2024011

Date: 26 Jan 2024 Time: 1505Z Position: 5152N 00035W Location: 1.5NM WSW Dunstable Downs

PART A: SUMMARY OF INFORMATION REPORTED TO UKAB

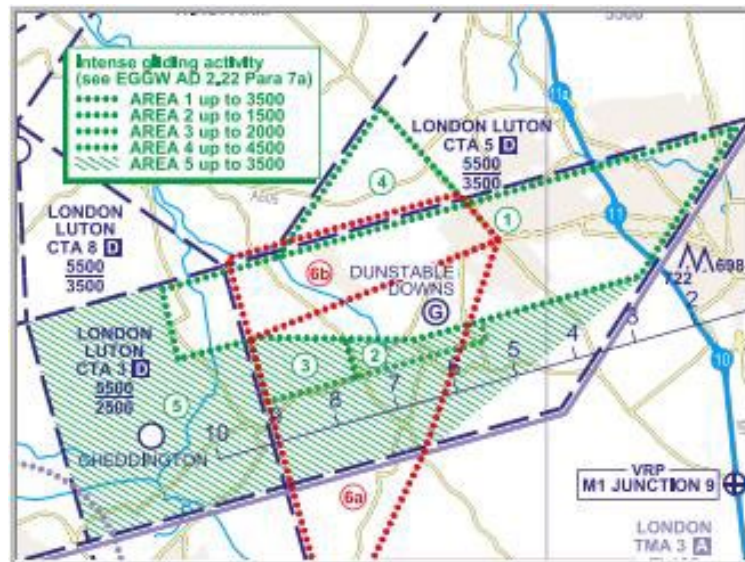
Figure 6 - ATS Airspace Vertical Limits

The Chiltern Soaring Ridge area, an extension of the Dunstable gliding area, was also not depicted on the VFR chart. The UK AIP provided lat/long co-ordinates of the extended gliding areas with altitude limits displayed, in addition to a chart displaying ATS Airspace Vertical Limits (see Figure 6), however these limits were not transposed onto the VFR chart.

As part of this investigation, it was observed that VFR charts did not depict the extent of the Dunstable Downs gliding area and its varied altitude limits. Pilot awareness of glider traffic locations on a VFR transit may therefore be uncertain and limited to the area surrounding Dunstable airfield.
