**AIRPROX REPORT No 2024015**

Date: 28 Jan 2024 Time: 1021Z Position: 5112N 00029W Location: Farley Green

**PART A: SUMMARY OF INFORMATION REPORTED TO UKAB**

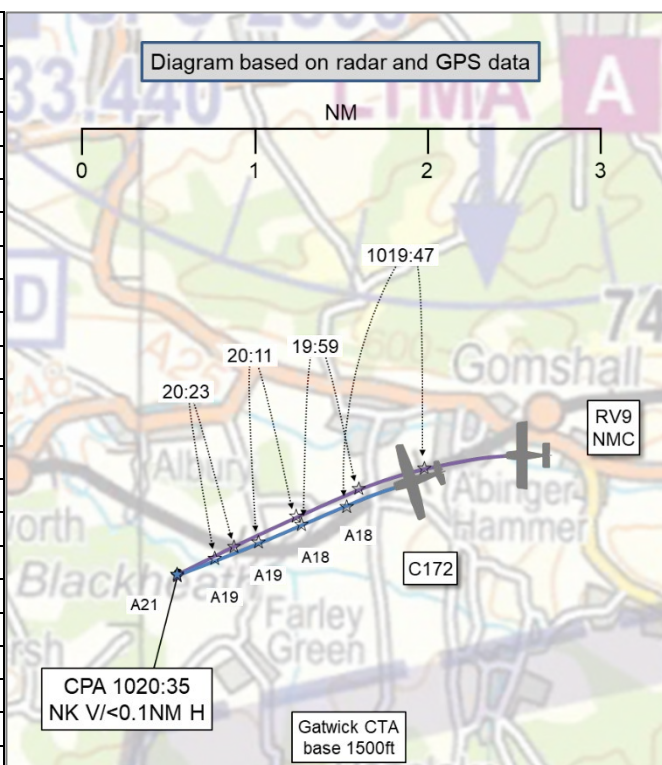
**THE C172 PILOT** reports in straight and level cruise in the ‘choke point between Gatwick zone and Farnborough’ when they received a traffic alert from their TAS. They scanned the sky and spotted a red RV9 pass directly below them from behind, approximately 100ft or less away. They pulled up to increase separation.

**THE RV9 PILOT** reports on a recreational flight outside controlled airspace to the north of Gatwick. They recalled the visibility being good with a slight haze. [The TAS] was enabled and connected to the navigation app. They did not recall how busy Farnborough was, but noted that often on a Sunday they were busy with GA traffic. They were content to listen out and rely on lookout from themselves and their passenger. At around mid-way between Dorking and Guildford, a contact appeared on the navigation app, ahead and slightly to starboard but no height information was displayed. They both looked for the traffic. They flew a manoeuvre to ‘clear the sky’ in front but neither of them saw another aircraft. They were firmly engaged in a 180° [lookout] scan from port to starboard and no longer had a view of the output from [the TAS]. Neither of the occupants picked up the other aircraft until the last minute, when they saw a high-wing SEP aircraft above and slightly to the right. They were unsure of the exact range but estimated ½NM. However, when it suddenly appeared, they hesitated because they were close to Gatwick on the port side. In a moment they considered their options. They could ram the stick forward and dive to port. A dive would be essential to avoid controlled airspace by 200ft and 2NM. They could turn to starboard but that [would have] closed the distance between them horizontally. They dismissed the dive to port for fear of an MOR. They glanced briefly at the GPS to check that they were around 2NM outside controlled airspace and noticed in the elapsed time that the corner of controlled airspace was approaching. With their eyes glued to the other aircraft they counted to 15, briefly glanced at the GPS, and executed a turn onto around 240° on the DI. On checking the GPS track there was a slight upward blip in altitude which may well be the point at which they were initially startled into action.

The C172 and RV9 pilots shared an equal responsibility for collision avoidance and not to operate in such proximity to other aircraft as to create a collision hazard.<sup>1</sup> If the incident geometry is considered as overtaking then the C172 pilot had right of way and the RV9 pilot was required to keep out of the way of the other aircraft by altering course to the right.<sup>2</sup>
