AIRPROX REPORT No 2024013

Date: 27 Jan 2024 Time: 1522Z Position: 5259N 00254W Location: 5NM SE Borrás Quarry VRP

PART A: SUMMARY OF INFORMATION REPORTED TO UKAB

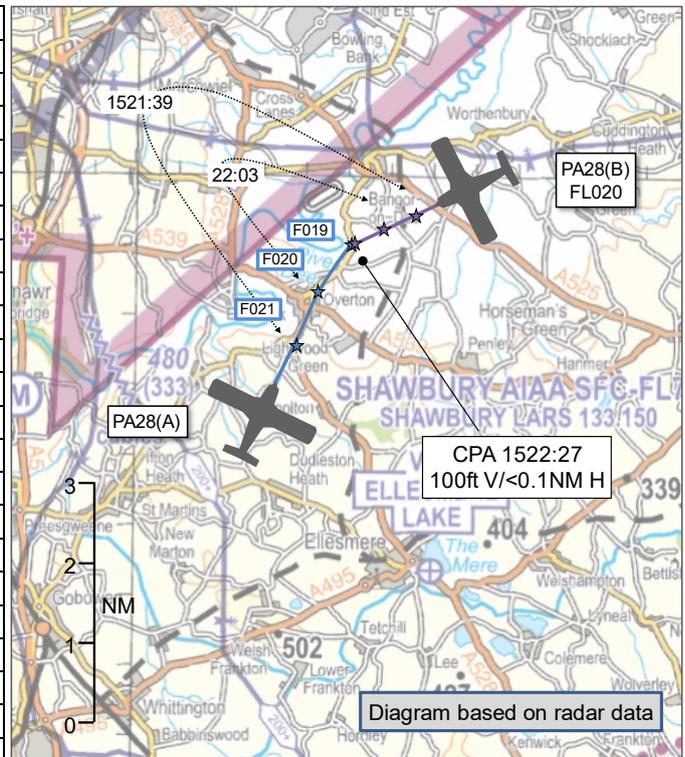
| Recorded | Aircraft 1 | Aircraft 2 |
|---|---|---|
| Reported | 100ft V/<0.5NM H | Not Seen |
| Recorded | 100ft V/<0.1NM H | |
