AIRPROX REPORT No 2024052

Date: 14 Apr 2024 Time: 1051Z Position: 5123N 00238W Location: 3NM E Bristol Airport

PART A: SUMMARY OF INFORMATION REPORTED TO UKAB

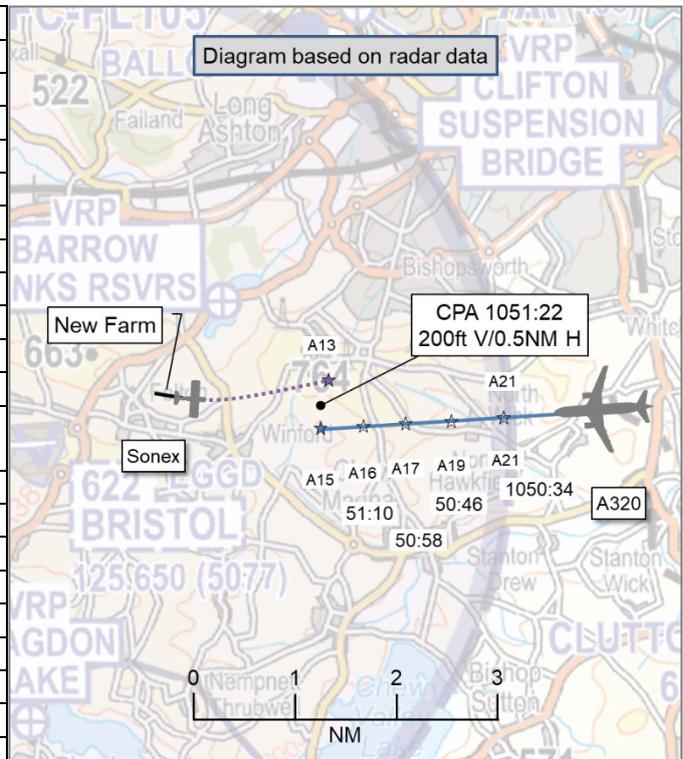
THE A320 PILOT reports that, when at 4NM on an ILS approach to RW27, the Tower controller advised them of 2 light-aircraft operating in the area. The nearest traffic was cleared by ATC to maintain 1200ft on departure from an airstrip and to remain north of the centreline. On final approach, passing 1000ft AGL, they had a TCAS TA followed very quickly by an RA. The light-aircraft appeared to be in a climbing left turn towards the centreline. The Captain saw the TCAS RA activate with the conflict indicating 500ft directly beneath and climbing. The TCAS RA was flown, followed by a missed approach. They were not visual with the conflicting traffic. The Tower controller was informed of the manoeuvre and no further calls were heard from them until frequency change back to Approach, although they heard the conflicting traffic pilot say they had visually identified them when asked by the Tower controller. The subsequent approach was uneventful. Neither crew saw the conflicting traffic.

instructed them to 'cross above and behind the A320' which was read back. By this time they were at about the same altitude as the A320, on a reciprocal heading and about 0.5NM to the north. After passing the A320 they heard a report of 'going around' on frequency and noticed the A320 begin to climb. When they judged it was safe to cross the A320 track, from a wake turbulence point of view, they turned south towards Chew Valley, now at about 1800ft. The flight continued as planned.

THE BRISTOL AERODROME CONTROLLER reports [Sonex C/S] wanted to depart from New Farm with [A320 C/S] on final 27 in sight of the controller and given traffic information on 2 aircraft. Clearance given to [Sonex C/S] to remain north of final approach and report the [A320 C/S] in sight. [Sonex C/S] confirmed in sight and reported airborne. [Sonex C/S] asked if they could cross final approach. They said negative and to confirm they had the aircraft in sight to which they said negative. They told [Sonex C/S] to remain north of final approach and to report the traffic in sight. [Sonex C/S] reported in sight. They told [Sonex C/S] to cross above and behind the [A320 C/S]. [A320 C/S] reported TCAS RA and went around.
