AIRPROX REPORT No 2024041

Date: 30 Mar 2024 Time: 1534Z Position: 5236N 00100W Location: Leicester ATZ

PART A: SUMMARY OF INFORMATION REPORTED TO UKAB

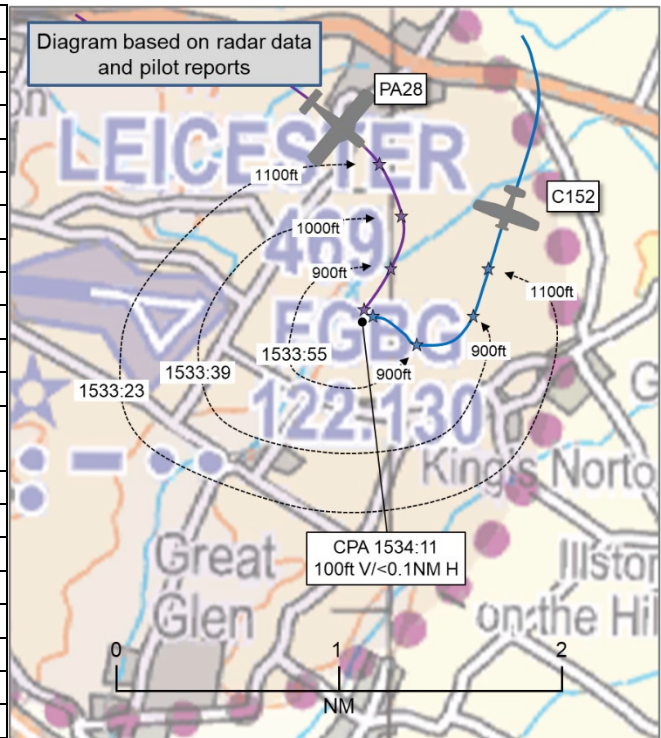
Recorded	Aircraft 1	Aircraft 2
Aircraft	C152	PA28
Operator	Civ FW	Civ FW
Airspace	Leicester ATZ	Leicester ATZ
Class	G	G
Rules	VFR	VFR
Service	AGCS	AGCS
Provider	Leicester Radio	Leicester Radio
Altitude/FL	800ft	700ft
Transponder	A, C, S	A, C, S
Reported		
Colours	White and blue	White
Lighting	Landing	Landing, beacon, strobes
Conditions	VMC	VMC
Visibility	>10km	>10km
Altitude/FL	700ft	650ft
Altimeter	QFE (976hPa)	QFE
Heading	280°	180°
Speed	65kt	70kt
ACAS/TAS	Not fitted	PilotAware
Alert	None	None
Separation at CPA		
Reported	200ft V/300-400ft H	100ft V/0.4NM H
Recorded	100ft V/<0.1NM H
