AIRPROX REPORT No 2024026

Date: 27 Feb 2024 Time: 1602Z Position: 5109N 00146W Location: Boscombe Down (406ft)

PART A: SUMMARY OF INFORMATION REPORTED TO UKAB

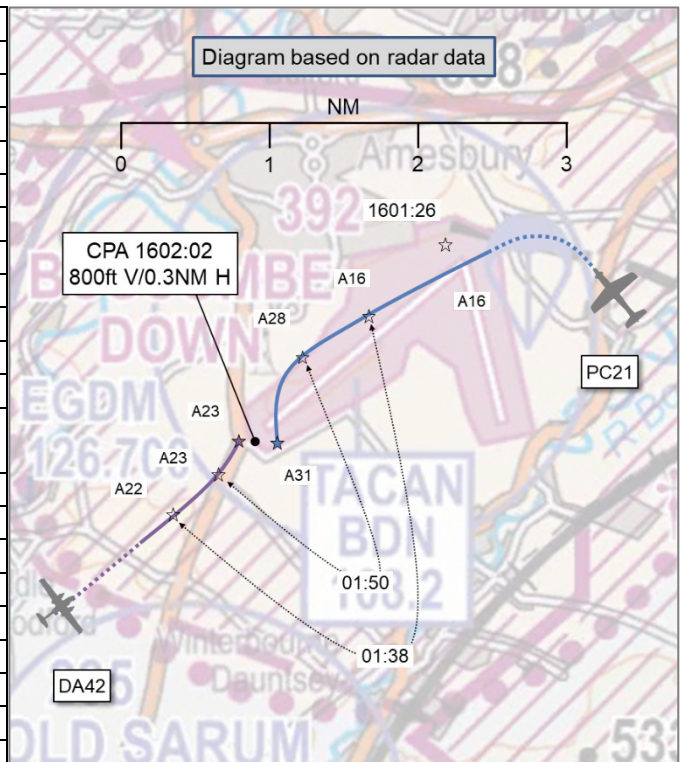
Recorded	Aircraft 1	Aircraft 2
Aircraft	PC21	DA42
Operator	MoD ATEC	Civ Comm
Airspace	Boscombe MATZ	Boscombe ATZ
Class	G	G
Rules	VFR	VFR
Service	ACS	Traffic
Provider	Boscombe Tower	Boscombe App
Altitude/FL	3100ft	2300ft
Transponder	A, C, S+	A, C, S+
Reported		
Colours	Red, white, blue	White, blue
Lighting	Nav, HISL, landing	Landing, taxi, nav, strobes
Conditions	VMC	VMC
Visibility	NR	>10km
Altitude/FL	2500ft	1800ft
Altimeter	NR (NR hPa)	QFE (NR hPa)
Heading	230°	050°
Speed	NR	130kt
ACAS/TAS	TAS	TAS
Alert	TA	TA
Separation at CPA		
Reported	500ft V/<0.5NM H	200ft V/1000m H
Recorded	800ft V/0.3NM H

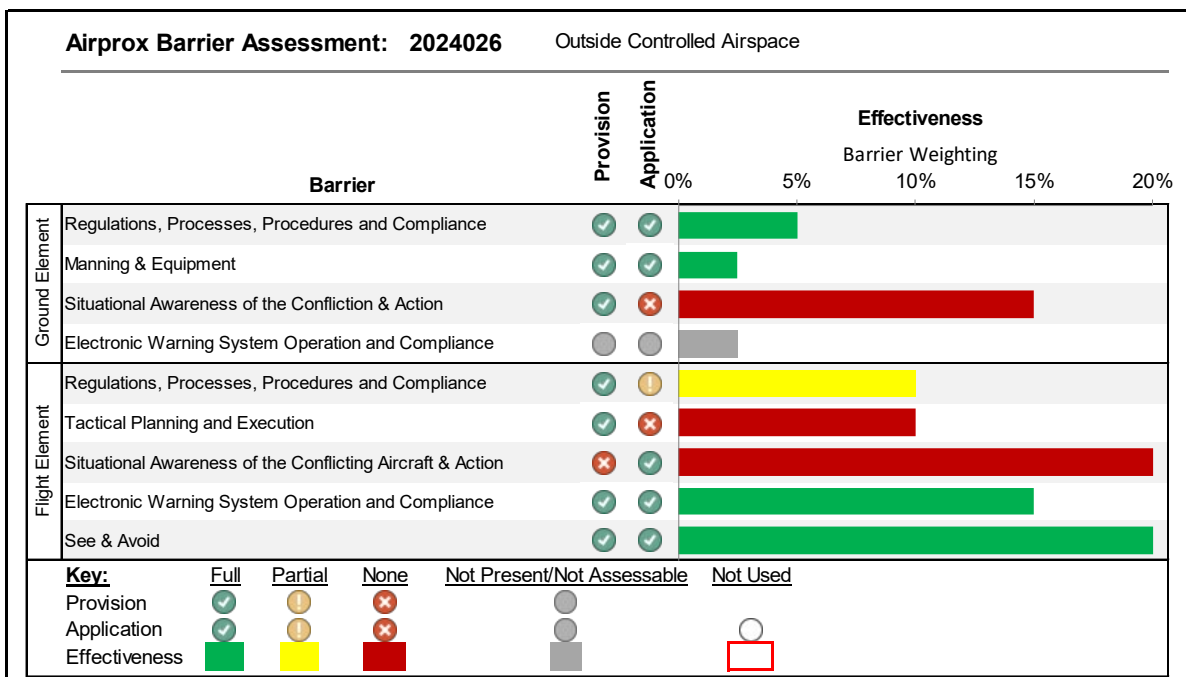
Tactical Planning and Execution was assessed as **ineffective** because the DA42 pilot commenced an approach to RW05 without declaring their intentions.

Situational Awareness of the Conflicting Aircraft and Action were assessed as **ineffective** because the PC21 pilot had no situational awareness of the approaching DA42.
