**AIRPROX REPORT No 2024016**

Date: 30 Jan 2024 Time: 1406Z Position: 5155N 00209W Location: Gloucestershire Airport ATZ

**PART A: SUMMARY OF INFORMATION REPORTED TO UKAB**

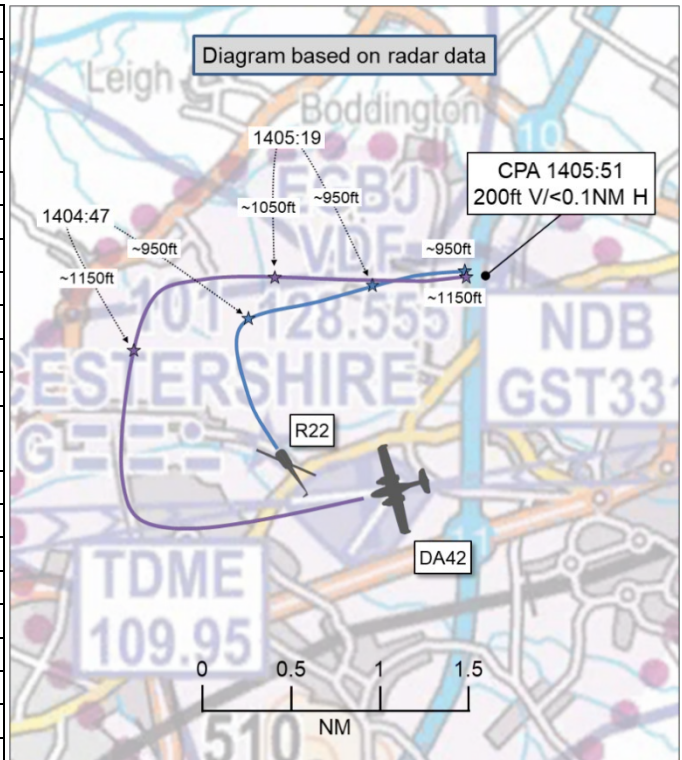
Recorded	Aircraft 1	Aircraft 2
Aircraft	R22	DA42
Operator	Civ Helo	Civ FW
Airspace	Gloster ATZ	Gloster ATZ
Class	G	G
Rules	VFR	VFR
Service	ACS	ACS
Provider	Gloster Tower	Gloster Tower
Altitude/FL	~950ft	~1150ft
Transponder	A, C, S	A, C, S+
<b>Reported</b>		
Colours	Red	White
Lighting	Nav, strobe	Nav, strobes, wing-tips
Conditions	VMC	VMC
Visibility	>10km	>10km
Altitude/FL	750ft	950ft
Altimeter	QFE (1027hPa)	QNH (1030hPa)
Heading	180°	150°
Speed	70kt	100kt
ACAS/TAS	Not fitted	TAS
Alert	N/A	TA
<b>Separation at CPA</b>		
Reported	100ft V/30m H	200ft V/100ft H
Recorded	200ft V/<0.1NM H
