AIRPROX REPORT No 2024018

Date: 01 Feb 2024 Time: 1406Z Position: 5257N 00034W Location: Barkston Heath ATZ

PART A: SUMMARY OF INFORMATION REPORTED TO UKAB

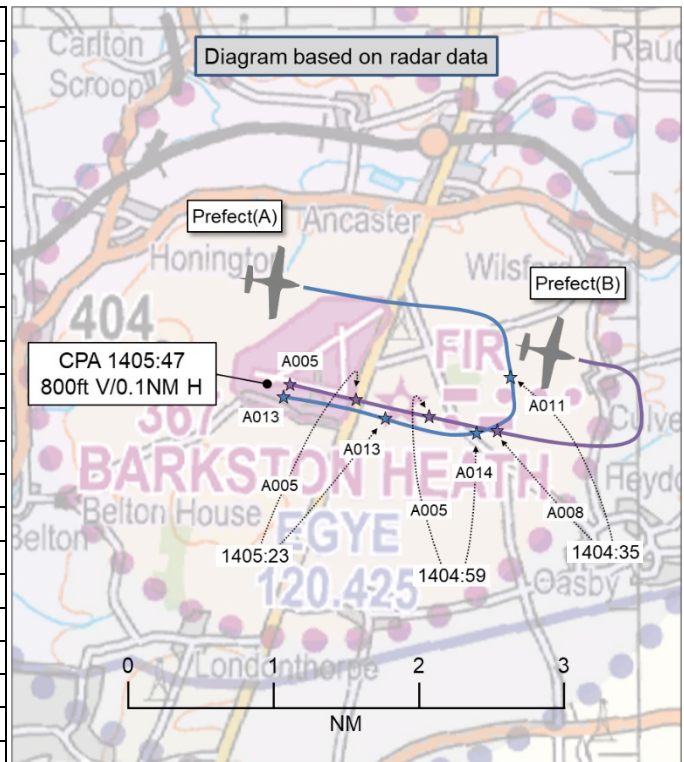
Recorded	Aircraft 1	Aircraft 2
Aircraft	Prefect(A)	Prefect(B)
Operator	HQ Air (Trg)	HQ Air (Trg)
Airspace	Barkston Heath ATZ	Barkston Heath ATZ
Class	G	G
Rules	VFR	VFR
Service	ACS	ACS
Provider	Barkston Tower	Barkston Tower
Altitude/FL	1300ft	500ft
Transponder	A, C, S	A, C, S
Reported		
Colours	Blue, white	NR
Lighting	Strobes	Strobes, nav
Conditions	VMC	VMC
Visibility	NR	NR
Altitude/FL	1000ft	300ft
Altimeter	NR	NR
Heading	NR	NR
Speed	120kt	120kt
ACAS/TAS	TCAS I, FLARM	TCAS I, FLARM
Alert	None	TA
Separation at CPA		
Reported	NR	NR
Recorded	800ft V/0.1NM H
