**AIRPROX REPORT No 2024023**

Date: 12 Feb 2024 Time: 1659Z Position: 5120N 00055W Location: 2.5NM west of Blackbushe

**PART A: SUMMARY OF INFORMATION REPORTED TO UKAB**

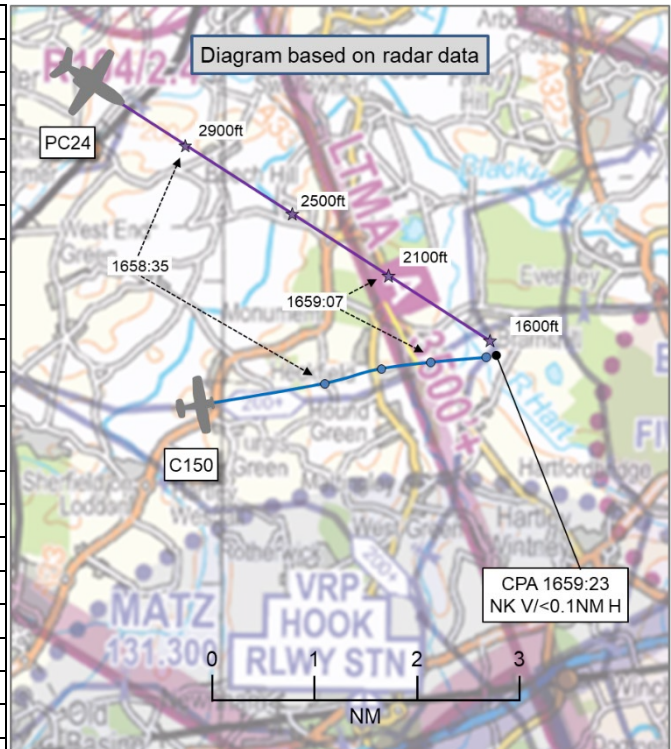
[The reported Airprox], a conflict between the PC24 and the C150 which the Blackbushe AFISO had not witnessed, nor had it been reported at the time, had happened outside the ATZ when they had not been working either aircraft.
