AIRPROX REPORT No 2024075

Date: 04 May 2024 Time: 1042Z Position: 5228N 00020W Location: 3NM W of Peterborough/Conington

PART A: SUMMARY OF INFORMATION REPORTED TO UKAB

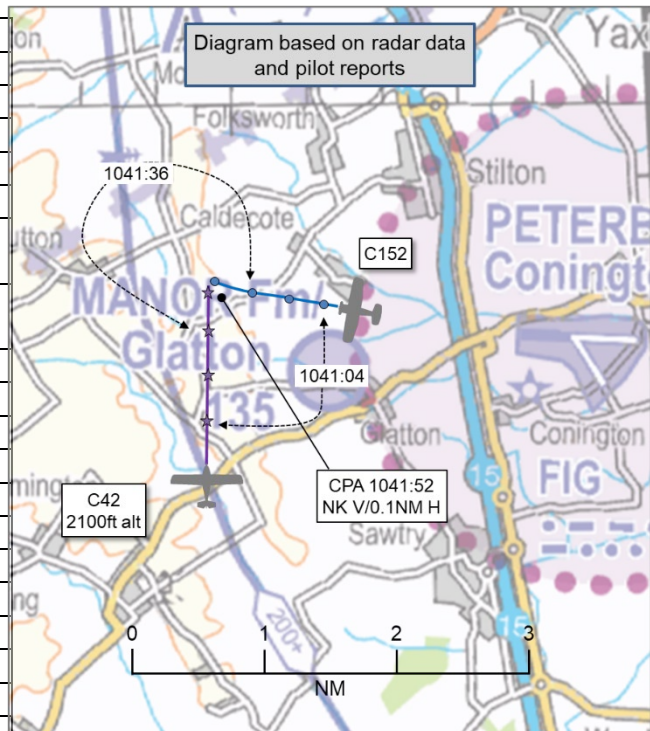
THE C152 PILOT reports that, whilst levelling off after climb-out from Conington on RW28 and shortly after departing the ATZ, they had seen another aircraft slightly above and in their 10 o'clock position. It seemed very close and had been close enough to read its registration. The C152 pilot made a turn to the right to increase separation then carried on their intended heading so that the other aircraft would pass behind them. They believed at the time that their transponder had been turned on and broadcasting Modes A, C, S, although they became aware a little later in the flight that it may not have been. If it had not been turned on, this could have been possibly due to having been distracted by a helicopter taking off from Conington ahead of them when lining up for take-off. The C152 pilot noted that their aircraft displays traffic via a [branded traffic display device], but no warnings had been noticed. They noted that they had been in the process of levelling-off from climb-out after take-off, changing frequency enroute and turning to their desired enroute heading, so workload at the time had been high.

THE C42 PILOT reports that they had been completing a student solo flight where they had taken off from [departure airfield] and had been practising general handling and steep turns. They had been heading north back to the airfield following on from this and had been in straight and level flight, preparing to descend to circuit height and had begun to complete their airfield approach checks. All of a sudden, an aircraft which they had not seen until it had been almost right in front of them went past from their right side to the left, slightly in front of and below them. It had all happened very quickly and, as the aircraft had already passed, the C42 pilot took no action to avoid as it had no longer been necessary. They report that they had of course been looking out to the best of their ability but simply had not seen this plane. They cannot be sure of the other plane's position prior to seeing it pass by quite closely.
