AIRPROX REPORT No 2024069

Date: 30 Apr 2024 Time: 0930Z Position: 5135N 00031W Location: Denham ATZ

PART A: SUMMARY OF INFORMATION REPORTED TO UKAB

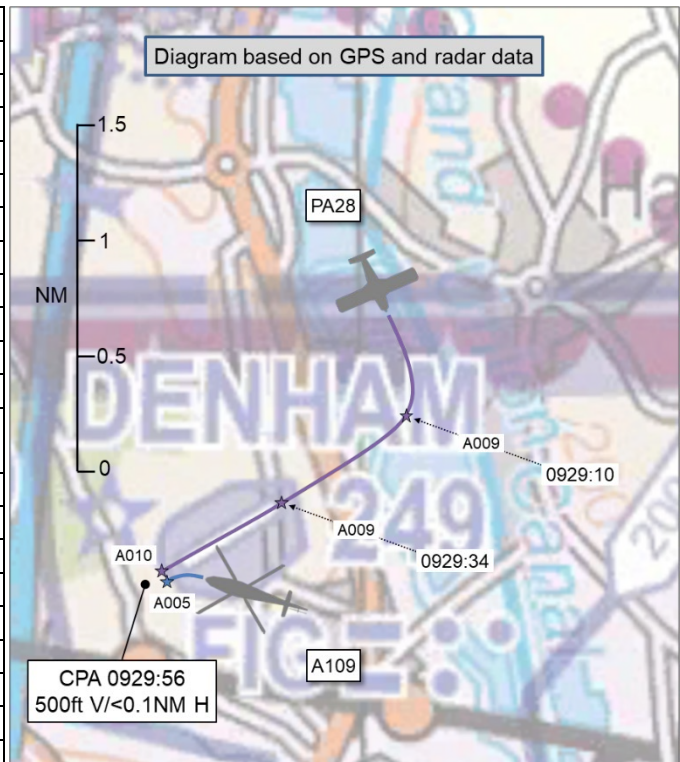
Recorded	Aircraft 1	Aircraft 2
Aircraft	A109	PA28
Operator	Civ Comm	Civ FW
Airspace	Denham ATZ	Denham ATZ
Class	D	D
Rules	VFR	VFR
Service	AGCS	Establishing RCS
Provider	Denham Radio	Heathrow SVFR
Altitude/FL	500ft	1000ft
Transponder	A, C, S	A, C, S
Reported		
Colours	Grey	White, blue, red
Lighting	Position, anti-col, strobe, landing	Landing, strobes, beacon
Conditions	VMC	VMC
Visibility	>10km	>10km
Altitude/FL	800ft	1000ft
Altimeter	QNH (1012hPa)	QNH (1012hPa)
Heading	240°	240°
Speed	80kt	95kt
ACAS/TAS	TAS	PilotAware
Alert	None	None
Separation at CPA		
Reported	100ft V/100m H	"not seen"
Recorded	500ft V/<0.1NM H
