AIRPROX REPORT No 2024065

Date: 26 Apr 2024 Time: 1023Z Position: 5211N 00002W Location: 3NM E Gransden Lodge

PART A: SUMMARY OF INFORMATION REPORTED TO UKAB

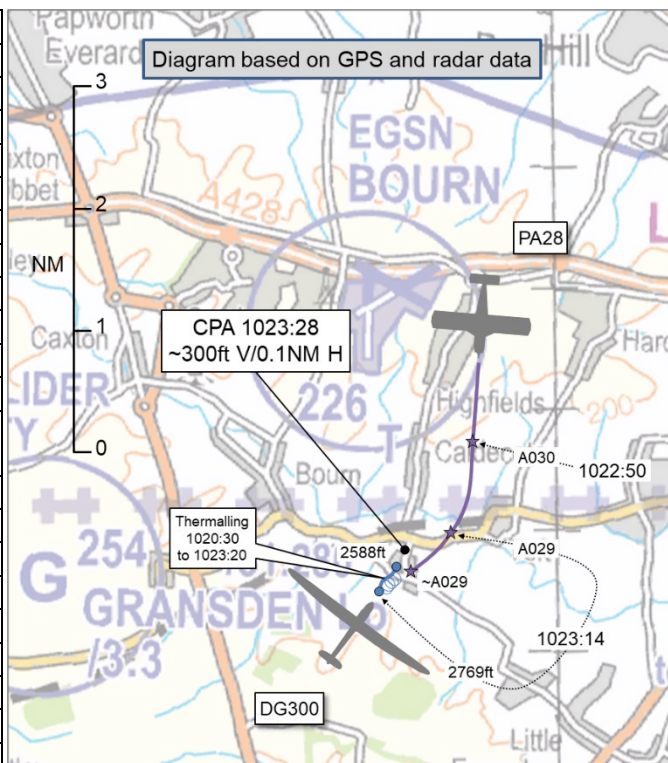
THE DG300 PILOT reports that, at 1023:20, they were about to reach cloudbase, climbing through ~2600ft QFE, turning right in a thermal above the village of Kingston. They sighted a powered aircraft, [the PA28], approaching approximately head-on. At that instant in the turn their heading was roughly 045°. The [PA28] was on a relative bearing of 355° from them and they estimate that [the DG300] had been at a relative heading of 020° from the [pilot of the PA28].

They exited the turn and initiated a negative-G dive simultaneously. This left horizontal separation unchanged and increased vertical separation to a few hundred feet by the time CPA was reached 5-10sec later. At CPA, the aircraft passed ~300ft above and ~100m to their right on a reciprocal heading. They were able to make out a blue colour scheme and read the underwing registration, [PA28 callsign]. They saw no evidence of having been sighted. They judge [that there had been] a high risk of collision if they had they not sighted [the PA28] but had continued the thermalling turn.
