**AIRPROX REPORT No 2024059**

Date: 21 Apr 2024 Time: 1129Z Position: 5217N 00052W Location: 2.5NM W of Sywell

**PART A: SUMMARY OF INFORMATION REPORTED TO UKAB**

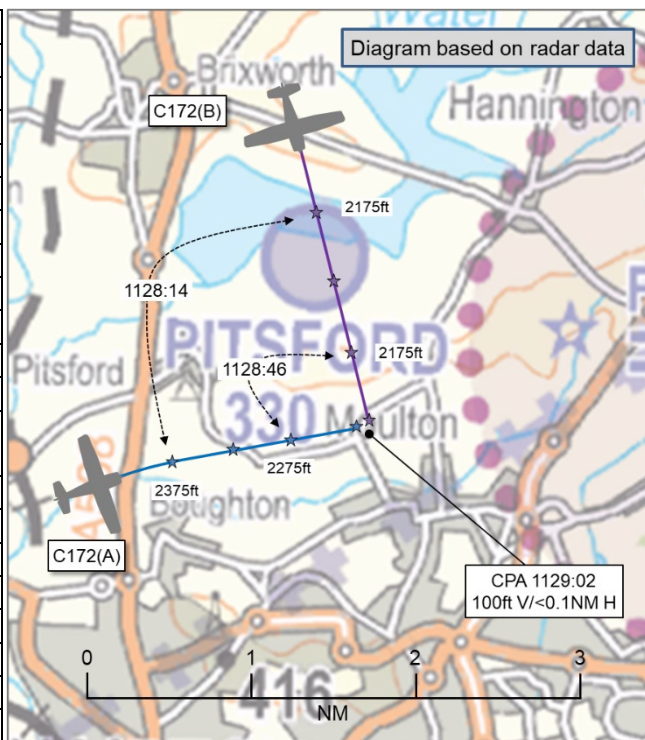
Recorded	Aircraft 1	Aircraft 2
Aircraft	C172(A)	C172(B)
Operator	Civ FW	Civ FW
Airspace	London FIR	London FIR
Class	G	G
Rules	VFR	VFR
Service	AGCS	Unknown
Provider	Sywell Radio	Unknown
Altitude/FL	2275ft	2175ft
Transponder	A, C, S	A, C, S
<b>Reported</b>		
Colours	Orange and white	White and blue
Lighting	Beacon, navigation, landing	Beacon, strobes, landing
Conditions	VMC	VMC
Visibility	>10km	>10km
Altitude/FL	2000ft	2000ft
Altimeter	QFE (1016hPa)	QNH
Heading	070°	170°
Speed	90kt	90kt
ACAS/TAS	SkyEcho	Not fitted
Alert	None	N/A
<b>Separation at CPA</b>		
Reported	100-200ft V/100-200ft H	500ft V/0.5NM H
Recorded	100ft V/<0.1NM H
