AIRPROX REPORT No 2024109

Date: 02 Jun 2024 Time: 1234Z Position: 5131N 00409W Location: 6NM SSW of Swansea Airport

PART A: SUMMARY OF INFORMATION REPORTED TO UKAB

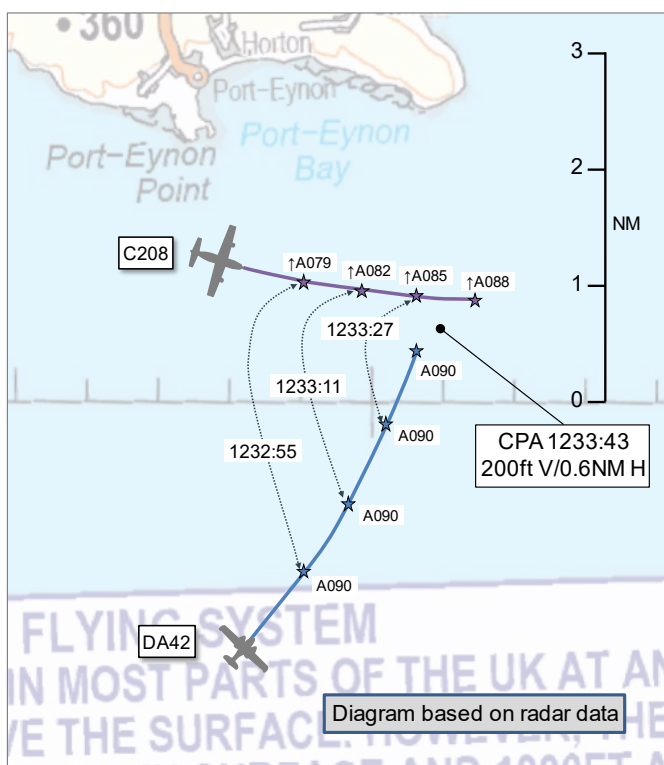
After a short time, Western Radar advised them to proceed "direct [waypoint]", and they complied. This would take them east of their intended route, and just east of the Swansea drop-zone, rather than just west of it. As they approached Swansea, [the controller] called "traffic, 11 o'clock, four miles, 2400[ft] below, climbing, left-to-right, parachute aircraft." They advised that the traffic was not sighted, and selected the 'Traffic' page on their [Electronic Flight Instrument System (EFIS)]. The display was clear, but they changed the mode from 'unrestricted' to 'normal' anyway to prioritise only proximate traffic, should any appear. The range setting was appropriately set on both [the EFIS] and the primary flight display (PFD) Traffic Alerting System (TAS) inset display. The radar controller soon came back with "previously called traffic, 11 o'clock, two miles, 1000[ft] below, still climbing". Despite excellent weather conditions, they still had not visually acquired the target, and the TAS display was still clear (both the PFD inset and the 'Traffic' page). They advised that they would turn left to avoid and, as they began the manoeuvre, they reported the traffic in sight. The controller replied, "own navigation [waypoint]". As they manoeuvred behind the parachute aircraft, safely separated and unbroken visual contact after the initial acquisition, the TAS announced a bearingless target at 1NM range. The TAS displays were still clear, as would be expected with a bearingless target. The C208 was at the same level as they passed through its six o'clock. Once clear of the traffic they resumed their route.
