AIRPROX REPORT No 2024111

Date: 05 Jun 2024 Time: 0733Z Position: 5203N 00036W Location: Cranfield

PART A: SUMMARY OF INFORMATION REPORTED TO UKAB

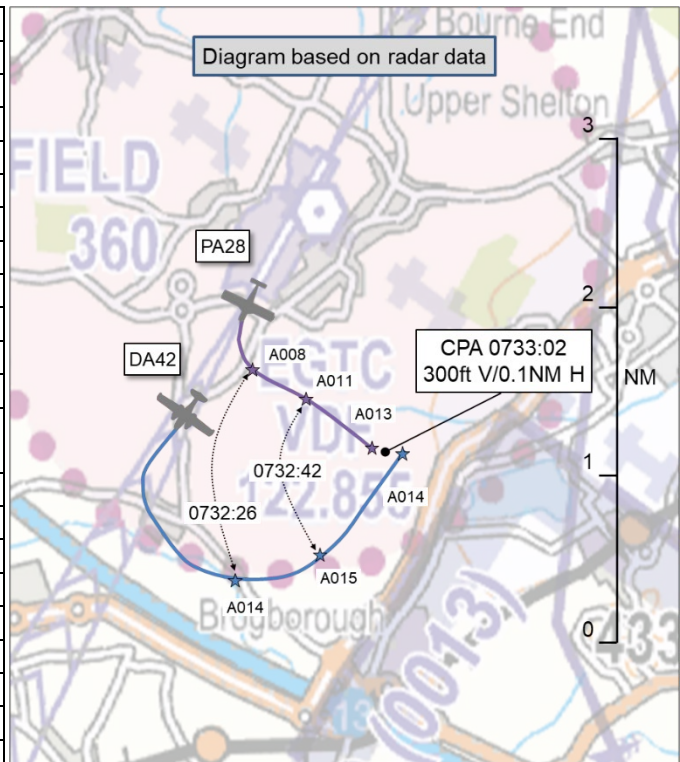
An analysis of the NATS radar replay was made and both aircraft were positively identified using Mode S data. CPA was determined to have been at 0733:02 (Figure 1).
