AIRPROX REPORT No 2024112

Date: 04 Jun 2024 Time: 1020Z Position: 5154N 00210W Location: Gloucestershire Airport

PART A: SUMMARY OF INFORMATION REPORTED TO UKAB

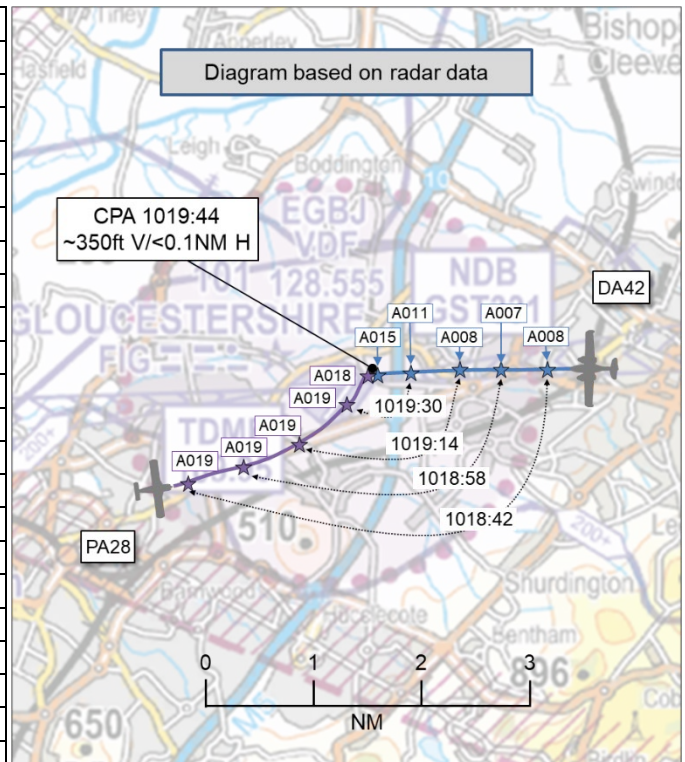
THE DA42 PILOT reports that during the go-around from an RNP approach for RW27 from 600ft they climbed heading 264° and, on passing 1000ft on the QNH, they did an ‘engine failure after take-off’ (EFATO) practise. With the aircraft nose high, doing 82kt, the student carried out the touch drill and, halfway through the drill, they looked out to see the PA28 in a slight descending turn which was going to pass down their left-hand side. At some point after that, the student had paused for them to give zero thrust, they called a near miss and advanced the throttle. Tower asked if they wanted to pass the details but they said that they would call when they were on the ground, which they did.
