**AIRPROX REPORT No 2024093**

Date: 20 May 2024 Time: 1620Z Position: 5412N 00113W Location: 1.5NM S Sutton Bank

**PART A: SUMMARY OF INFORMATION REPORTED TO UKAB**

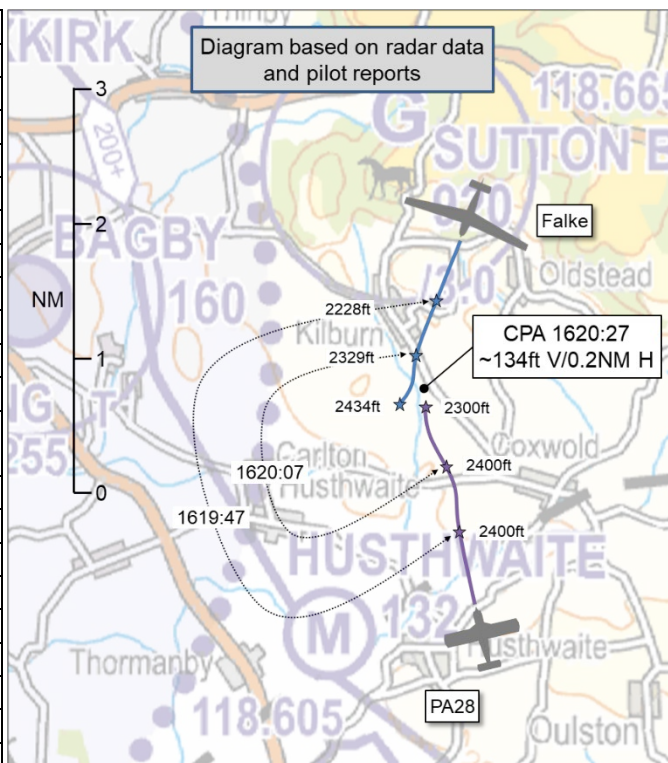
Recorded	Aircraft 1	Aircraft 2
Aircraft	Falke	PA28
Operator	Civ Gld	Civ FW
Airspace	London FIR	London FIR
Class	G	G
Rules	VFR	VFR
Service	Listening Out	Unknown
Provider	Sutton Bank traffic	N/A
Altitude/FL	2434ft	2300ft
Transponder	A, C	A, C, S
<b>Reported</b>		
Colours	Green, white	White, green
Lighting	White strobe	Nav, anti-col, HISL, beacon
Conditions	VMC	VMC
Visibility	>10km	5-10km
Altitude/FL	1500ft	2500ft
Altimeter	QFE	NR
Heading	170°	190°
Speed	80kt	90kt
ACAS/TAS	FLARM	Not fitted
Alert	None	N/A
<b>Separation at CPA</b>		
Reported	0ft V/50m H	NR
Recorded	~134ft V/0.2NM H
