**AIRPROX REPORT No 2024094**

Date: 19 May 2024 Time: 1607Z Position: 5535N 00521W Location: Dougarie Point, Isle of Arran

**PART A: SUMMARY OF INFORMATION REPORTED TO UKAB**

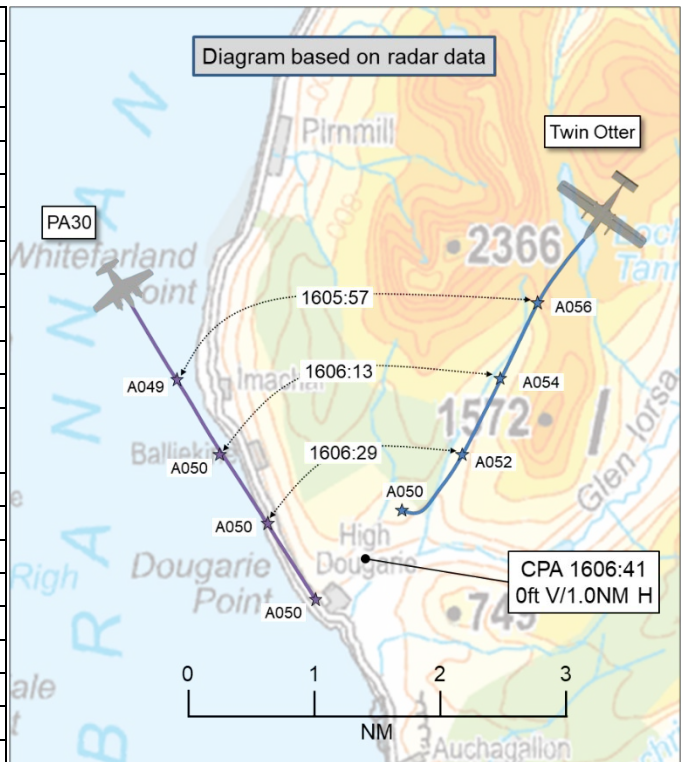
Recorded	Aircraft 1	Aircraft 2
Aircraft	Twin Otter	PA30
Operator	CAT	Civ FW
Airspace	Scottish FIR	Scottish FIR
Class	G	G
Rules	IFR	VFR
Service	Traffic	Basic
Provider	Scottish Control	Scottish Control
Altitude/FL	5000ft	5000ft
Transponder	A, C, S	A, C, S
<b>Reported</b>		
Colours	Blue/White	White/red & blue
Lighting	Strobes and nav lights.	Beacon and strobes
Conditions	VMC	VMC
Visibility	>10km	>10km
Altitude/FL	5000ft	5000ft
Altimeter	QNH	QNH
Heading	200°	135°
Speed	140kt	160kt
ACAS/TAS	TCAS II	Not fitted
Alert	RA	N/A
<b>Separation at CPA</b>		
Reported	400ft V/<1NM H	NK V/NK H
Recorded	0ft V/1.0NM H

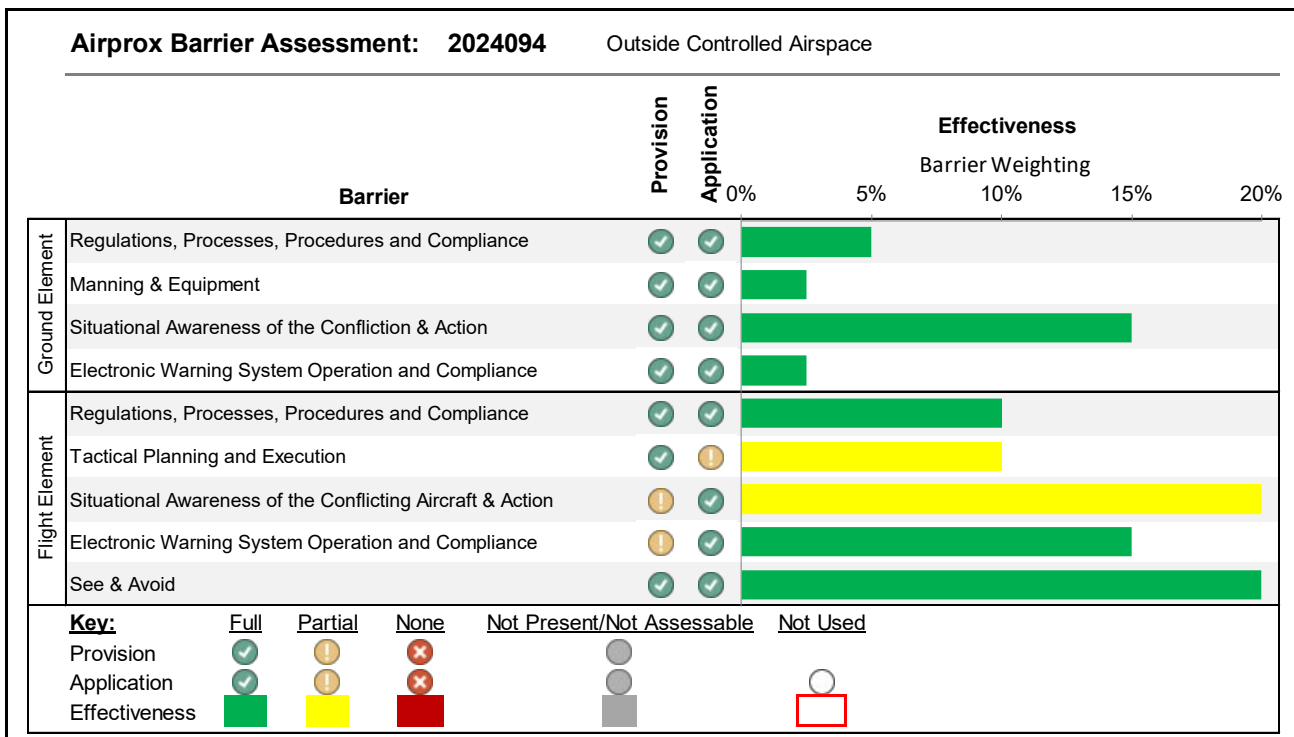
**Tactical Planning and Execution** was assessed as **partially effective** because the PA30 pilot had requested only a Basic Service when a Traffic service was available to them.

**Situational Awareness of the Conflicting Aircraft and Action** were assessed as **partially effective** because the PA30 pilot had only generic situational awareness of the Twin Otter's presence.
