AIRPROX REPORT No 2024099

Date: 24 May 2024 Time: 1122Z Position: 5157N 00117W Location: 5NM N Weston-on-the-Green

PART A: SUMMARY OF INFORMATION REPORTED TO UKAB

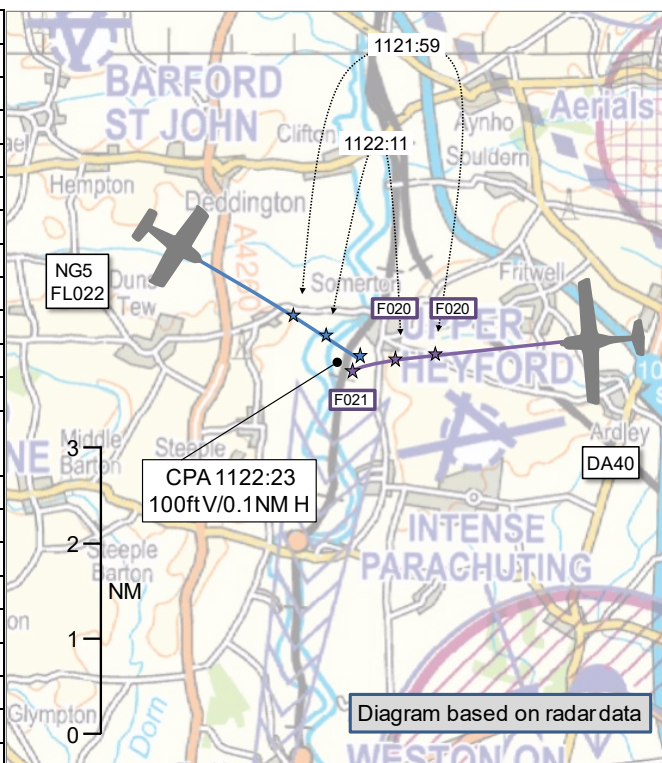
Recorded	Aircraft 1	Aircraft 2
Aircraft	Bristell NG5	DA40
Operator	Civ FW	Civ FW
Airspace	London FIR	London FIR
Class	G	G
Rules	VFR	VFR
Service	Basic	Listening Out
Provider	London Info	Brize Radar
Altitude/FL	FL022	FL021
Transponder	A, C, S	A, C, S
Reported		
Colours	Blue, White	White
Lighting	Landing, Taxi, Nav, Strobe	Nav, Anti-cols, HISLs
Conditions	VMC	VMC
Visibility	>10km	5-10km
Altitude/FL	2300ft	2350ft
Altimeter	QNH (1019hPa)	QNH (1018hPa)
Heading	130°	270°
Speed	110kt	117kt
ACAS/TAS	PilotAware	Not fitted
Alert	None	N/A
Separation at CPA		
Reported	0ft V/200m H	Not Seen
Recorded	100ft V/0.1NM H
