AIRPROX REPORT No 2024108

Date: 25 May 2024 Time: 1130Z Position: 5213N 00138W Location: Wellesbourne ATZ

PART A: SUMMARY OF INFORMATION REPORTED TO UKAB

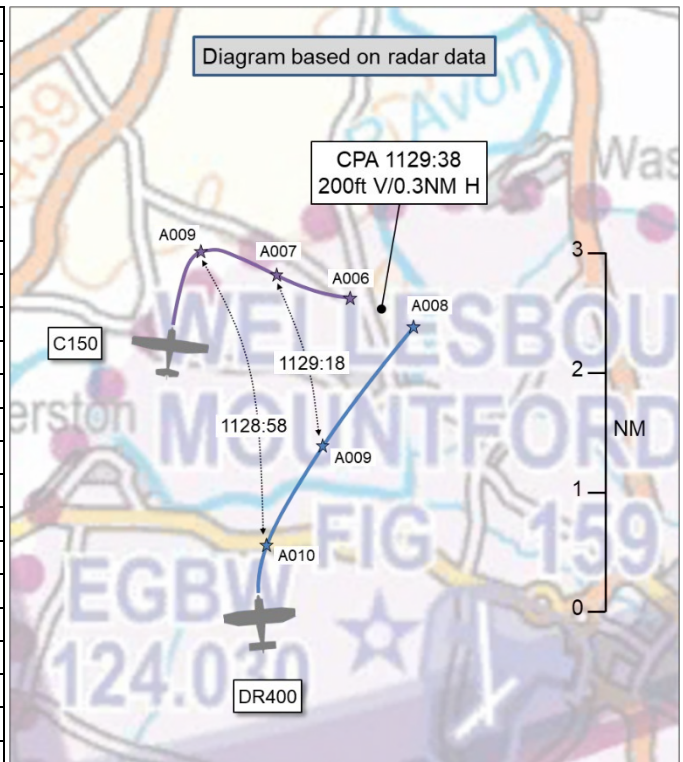
Recorded	Aircraft 1	Aircraft 2
Aircraft	DR400	C150
Operator	Civ FW	Civ FW
Airspace	Wellesbourne ATZ	Wellesbourne ATZ
Class	G	G
Rules	VFR	VFR
Service	AFIS	AFIS
Provider	Wellesbourne Info.	Wellesbourne Info.
Altitude/FL	800ft	600ft
Transponder	A, C, S	A, C, S
Reported		
Colours	Red, white	White, blue
Lighting	Strobes, nav	"yes"
Conditions	VMC	VMC
Visibility	5-10km	>10km
Altitude/FL	"Landing"	1200ft
Altimeter	QFE	QNH
Heading	"runway heading"	350°
Speed	<80kt	NK
ACAS/TAS	SkyEcho	Not fitted
Alert	Information ¹	N/A
Separation at CPA		
Reported	NK	500ft V/200m H
Recorded	200ft V/0.3NM H
