AIRPROX REPORT No 2024120

Date: 16 Jun 2024 Time: 1514Z Position: 5156N 00104W Location: 3NM NE Bicester

PART A: SUMMARY OF INFORMATION REPORTED TO UKAB

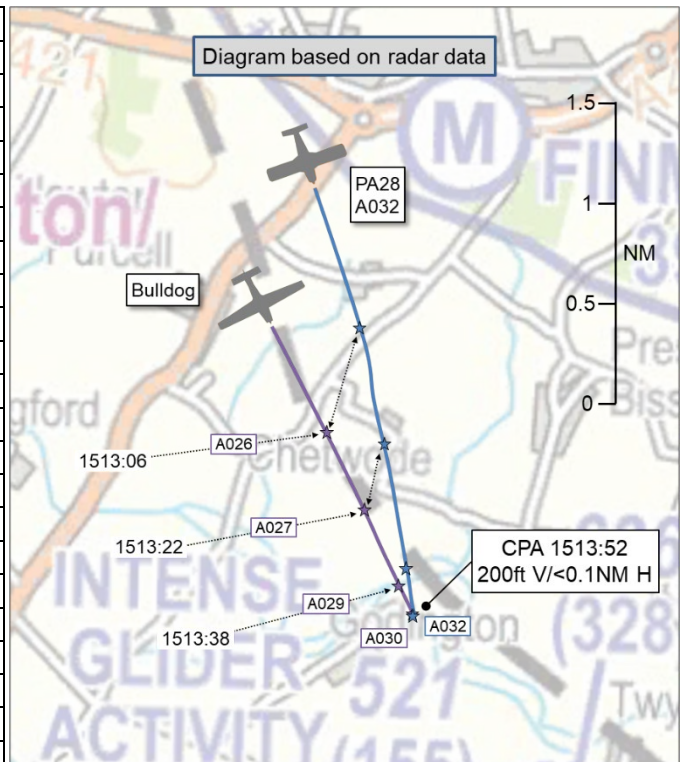
¹ The pilot of the Bulldog reported a separation at CPA of 200ft vertically and 0.33NM horizontally but, by reference to their narrative report, UKAB Secretariat assessed that that had not been a separation from the PA28 subject of this Airprox.
