AIRPROX REPORT No 2024134

Date: 21 Jun 2024 Time: 1337Z Position: 5204N 00041W Location: 2.5NM W of Cranfield

PART A: SUMMARY OF INFORMATION REPORTED TO UKAB

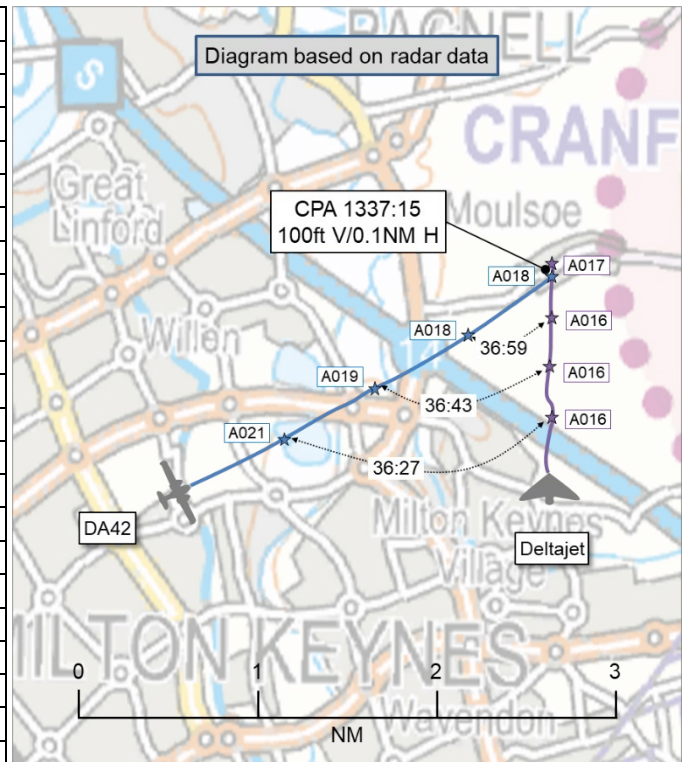
Recorded	Aircraft 1	Aircraft 2
Aircraft	DA42	Deltajet
Operator	Civ FW	Civ FW
Airspace	London FIR	London FIR
Class	G	G
Rules	VFR	VFR
Service	Basic	None
Provider	Cranfield APP	N/A
Altitude/FL	1800ft	1700ft
Transponder	A, C, S	A, C, S
Reported		
Colours	White	Orange
Lighting	"All ON"	none
Conditions	VMC	VMC
Visibility	>10km	>10km
Altitude/FL	1600ft	1000ft-2000ft
Altimeter	QNH (1011hPa)	QFE
Heading	090°	NK
Speed	115kt	60kt
ACAS/TAS	SkyEcho and TAS	Not fitted
Alert	None	N/A
Separation at CPA		
Reported	100ft V/1NM H	NK V/NK H
Recorded	100ft V/0.1NM H

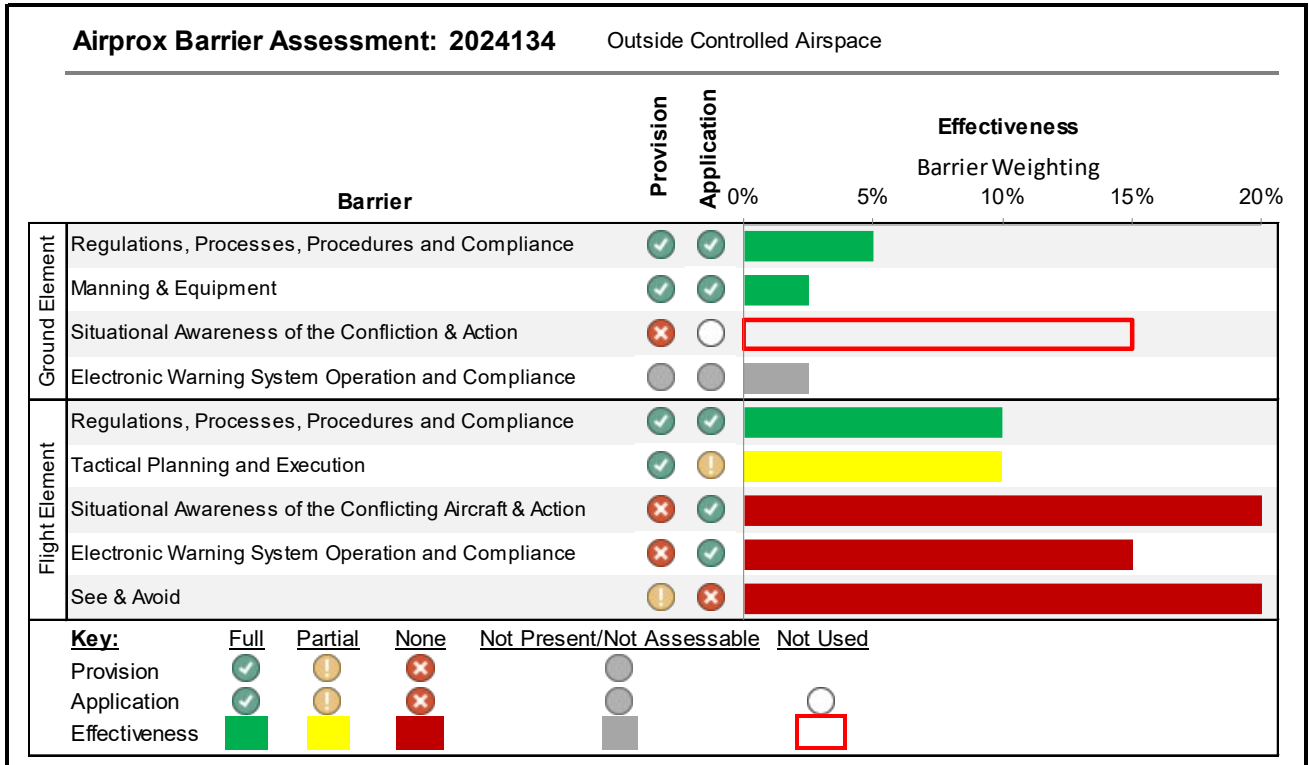
Safety Barrier Assessment⁴

Electronic Warning System Operation and Compliance were assessed as **ineffective** because the DA42's TAS had not detected the presence of the Deltajet and the DA42 pilot had turned off the screen for monitoring traffic detected by their additional EC device.

See and Avoid were assessed as **ineffective** because the DA42 pilot only saw the Deltajet after CPA, and the Deltajet pilot had not seen the DA42.
