AIRPROX REPORT No 2024151

Date: 26 Jun 2024 Time: 1536Z Position: 5119N 00052W Location: Blackbushe

PART A: SUMMARY OF INFORMATION REPORTED TO UKAB

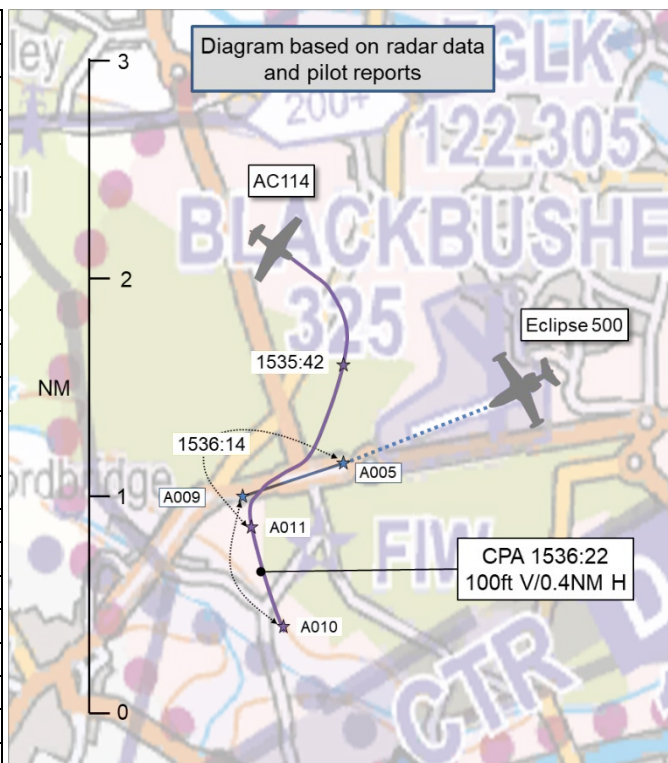
Recorded	Aircraft 1	Aircraft 2
Aircraft	Eclipse 500	AC114
Operator	Civ Comm	Civ FW
Airspace	Blackbushe ATZ	Blackbushe ATZ
Class	G	G
Rules	IFR	VFR
Service	AFIS	AFIS
Provider	Blackbushe Info	Blackbushe Info
Altitude/FL	900ft	1000ft
Transponder	A, C, S+	A, C, S
Reported		
Colours	White	White/Blue
Lighting	Nav, taxi, landing and strobe.	Nav, strobes, and anti-collision.
Conditions	VMC	VMC
Visibility	>10km	5-10km
Altitude/FL	NR	800ft
Altimeter	QNH (1011hPa)	QFE
Heading	250°	180°
Speed	85kt	110kt
ACAS/TAS	TCAS I	Other
Alert	TA	None
Separation at CPA		
Reported	300ft V/0.3NM H	NK V/NK H
Recorded	100ft V/0.4NM H
