AIRPROX REPORT No 2024159

Date: 05 Jul 2024 Time: 1524Z Position: 5215N 00018W Location: NE Cambridge Airport

PART A: SUMMARY OF INFORMATION REPORTED TO UKAB

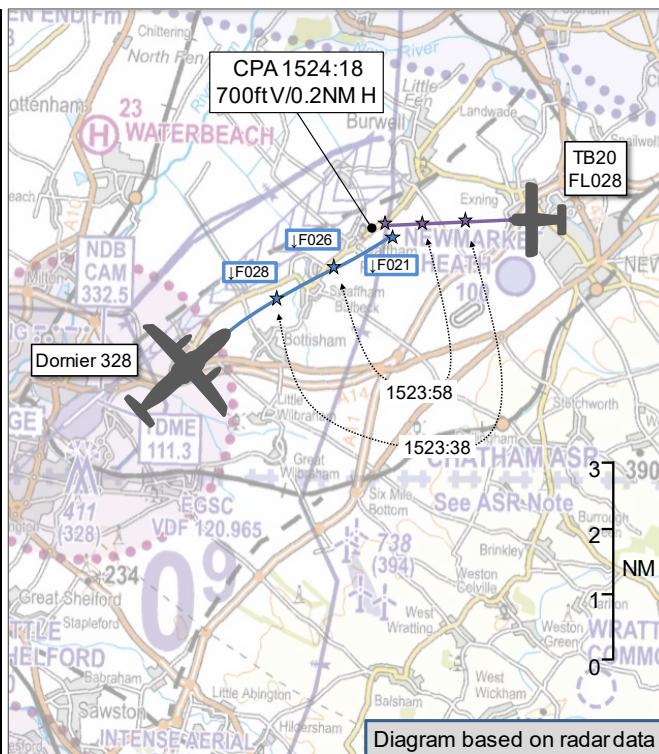
Recorded	Aircraft 1	Aircraft 2
Aircraft	Dornier 328	TB20
Operator	Civ Comm	Civ FW
Airspace	London FIR	London FIR
Class	G	G
Rules	IFR	VFR
Service	Procedural	Basic
Provider	Cambridge	Cambridge
Altitude/FL	FL021	FL028
Transponder	A, C, S+	A, C, S
Reported		
Colours	Company	NK
Lighting	NR	NK
Conditions	NK	NK
Visibility	>10km	NR
Altitude/FL	2000ft	NK
Altimeter	QNH (1004hPa)	NK
Heading	NR	NK
Speed	180kt	NK
ACAS/TAS	TCAS II	Unknown
Alert	RA	Unknown
Separation at CPA		
Reported	3-400ft V/0.5NM H	NR
Recorded	700ft V/0.2NM H
