AIRPROX REPORT No 2024166

Date: 18 Jul 2024 Time: 1423Z Position: 5213N 00029W Location: ivo Bedford Airfield

PART A: SUMMARY OF INFORMATION REPORTED TO UKAB

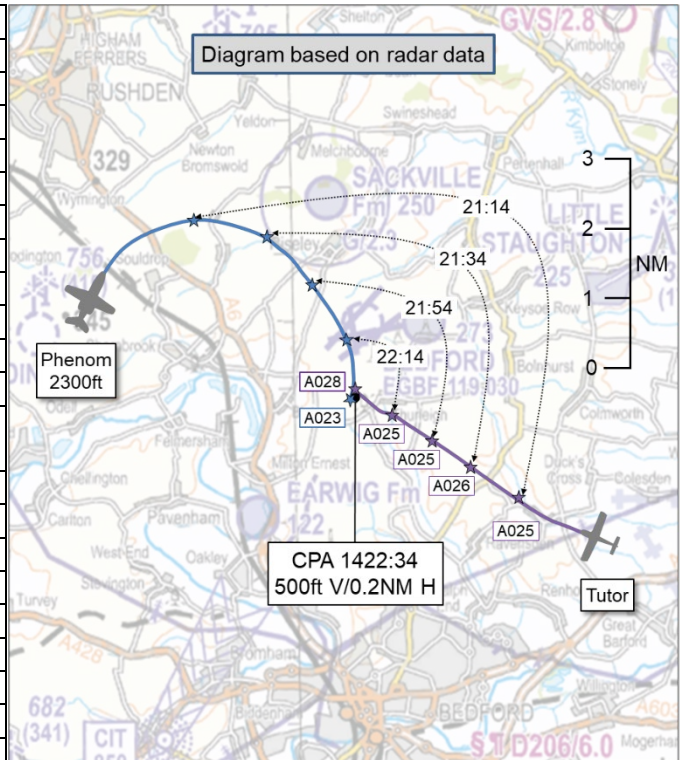
THE PHENOM 300 PILOT reports that, whilst conducting an instrument approach (RNP RW21 at Cranfield) and just turning inbound at the [intermediate] fix [TC21I], a TCAS contact was seen approaching from the opposite direction. The aircraft was acquired visually and a TCAS TA followed by a TCAS RA and the ‘monitor vertical speed’ command was actioned. The aircraft passed overhead and slightly above. Cranfield Tower was advised when they were clear of conflict and had tried to contact the other aircraft without success.

THE TUTOR PILOT reports that they were an experienced QFI on a medium level navigational exercise with a student pilot. The traffic had been reported to them by Wittering Zone and held on TAS, and they had [acquired the Phenom visually] at approximately 4NM, at a similar altitude. The landing light of the other aircraft showed no relative movement in their 2 o'clock position, signifying converging aircraft. They had waggled their wings to signal that they were visual with the other aircraft, but the other aircraft maintained heading and height and did not acknowledge their signal. Consequently they entered a 30° angle of bank gently climbing turn to the right whilst maintaining visual throughout to avoid the other aircraft, before reversing the turn to fit in behind them and return to their previous track. The closest point was in [the Phenom’s] rear left-hand quarter as they turned back behind with no further risk of collision. The other aircraft (civilian Embraer Phenom) [pilot] made no attempt to deviate from their original track.
