AIRPROX REPORT No 2024170

Date: 24 Jul 2024 Time: 1113Z Position: 5157N 00126W Location: Enstone

PART A: SUMMARY OF INFORMATION REPORTED TO UKAB

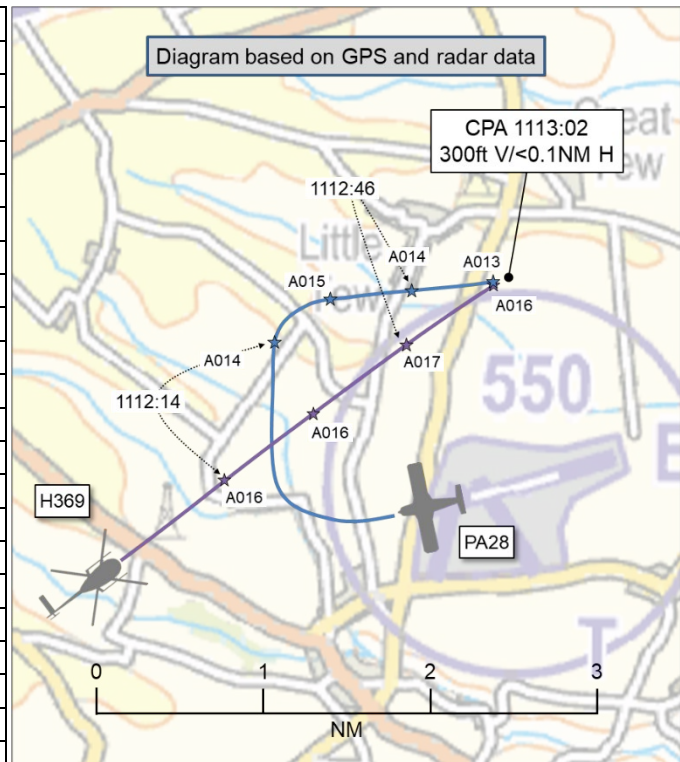
THE PA28 PILOT reports that this flight was conducted with a student practising circuits at Enstone and [they were] the FI as PIC. The aircraft was on the downwind leg on a heading of 080° at Enstone for RW26 right-hand circuit at 800ft QFE when a helicopter was sighted passing directly overhead (approximately 50ft above) on a slightly different heading. There was no communication on the radio on 129.880MHz and the helicopter continued on its track away from Enstone. No communication was made at all.

THE H369 PILOT reports that they saw an aircraft climbing-out from Enstone about 5km away. It turned crosswind still climbing. It then appeared to turn downwind. [The pilot of the H369] elected to stay on track and on heading, but with a gentle climb as they had visual with the aircraft the whole time. They eventually flew over the aircraft.
