AIRPROX REPORT No 2024176

Date: 27 Jul 2024 Time: 1409Z Position: 5154N 00107E Location: 1NM N Tendring

PART A: SUMMARY OF INFORMATION REPORTED TO UKAB

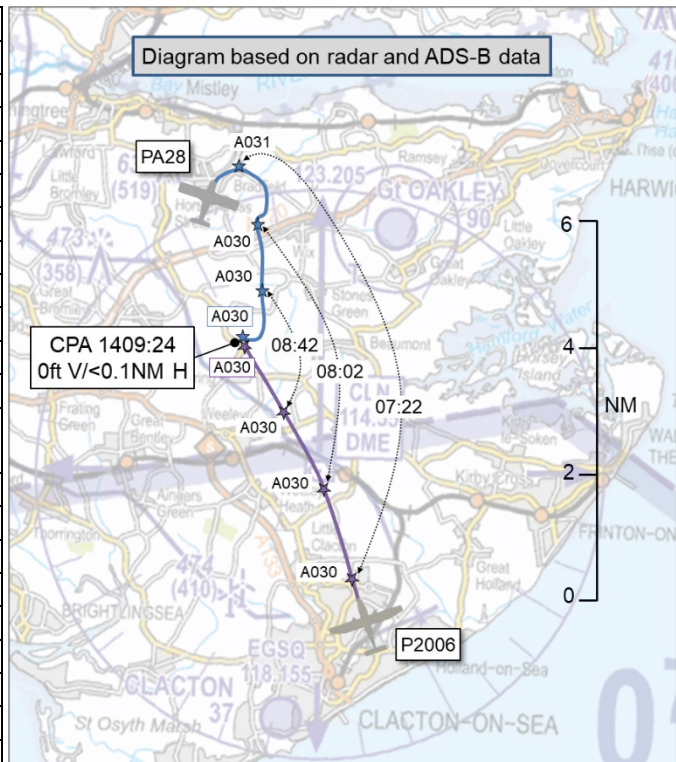
Recorded	Aircraft 1	Aircraft 2
Aircraft	PA28	P2006
Operator	Civ FW	Civ Comm
Airspace	London FIR	London FIR
Class	G	G
Rules	VFR	VFR
Service	Basic	Basic
Provider	Southend Radar	Southend Radar
Altitude/FL	3000ft	3000ft
Transponder	A, C, S	A, C, S
Reported		
Colours	White/Blue	Grey
Lighting	Strobes, beacon & navigation.	Navigation and strobes.
Conditions	VMC	VMC
Visibility	>10km	>10km
Altitude/FL	3000ft	3000ft
Altimeter	QNH	QNH
Heading	250°	320°
Speed	85kt	120kt
ACAS/TAS	Not fitted	Not fitted
Separation at CPA		
Reported	500ft V/100m H	NK V/NK H
Recorded	0ft V/<0.1NM H
