AIRPROX REPORT No 2024198

Date: 04 Aug 2024 Time: ~1055Z Position: 5107N 00134W Location: Middle Wallop ATZ

PART A: SUMMARY OF INFORMATION REPORTED TO UKAB

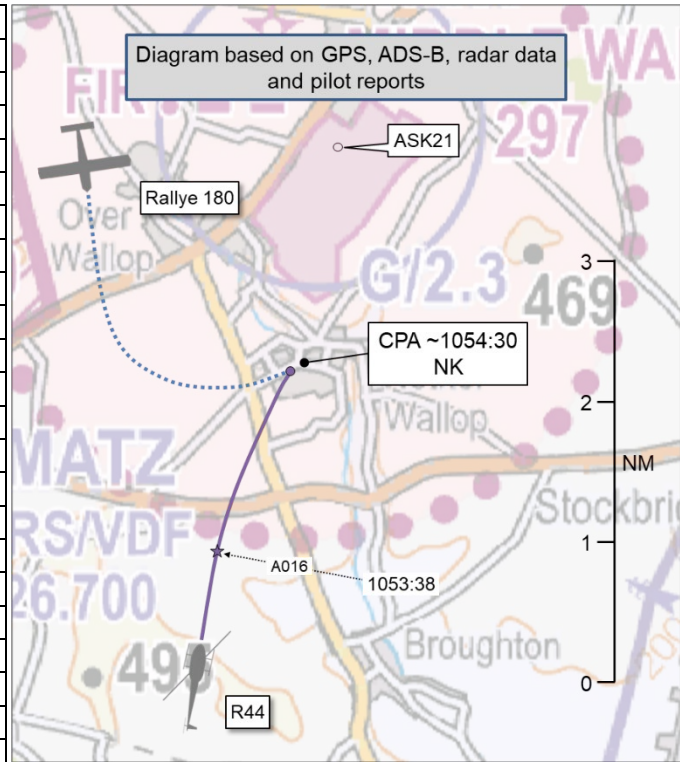
At 1054, they initiated a winch-launch for a glider pilot, [the witness in the ASK21], on RW26 after having checked and noted no conflicting traffic. That launch took around 60sec for the glider to climb to 1200ft AGL and start a thermalling turn. At 1055, a fast-moving helicopter was seen by them, and others on the ground, to transit from the south to north, in between the glider and the launch point, across the centre of the airfield and, without doubt, being well within the ATZ both horizontally and vertically. No radio call had been received, nor responded to.

The [ASK21] pilot reported that [the R44] looked to have passed a few hundred feet lower than them, just offset to the east.

[The Middle Wallop AGO opined that,] clearly, there was a serious risk of the helicopter contacting the winch cable if it had been a short period earlier. At the same instant, the tug aircraft, [the Rallye 180], was 1000ft AGL downwind, left-hand for RW26 (to the south). The tug pilot reported that the helicopter flew at almost a right-angle, immediately underneath them, at a height differential of only 100-200ft.

they heard the duty instructor announce on the radio (118.605MHz) that a winch launch was in progress. It was very shortly after that that they observed a black helicopter, possibly an R44, pass directly underneath them and continue across the airfield passing midway across RW26 (fortunately missing the winch launch). No radio communication was heard.

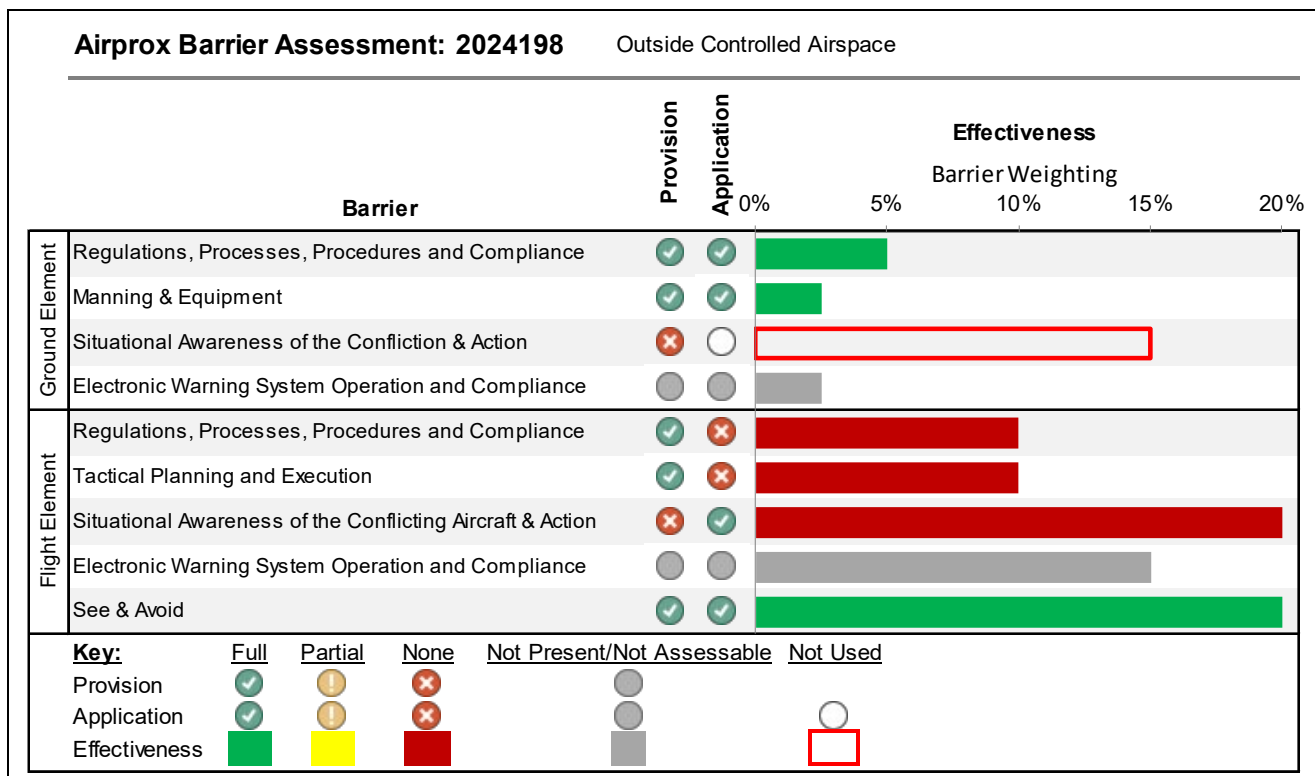
Tactical Planning and Execution was assessed as **ineffective** because the pilot of the R44 had entered the Middle Wallop ATZ without permission when it had been active.

Situational Awareness of the Conflicting Aircraft and Action were assessed as **ineffective** because neither pilot had situational awareness of the presence of the other aircraft until visually acquired.
