AIRPROX REPORT No 2024162

Date: 17 Jul 2024 Time: 1530Z Position: 5214N 00043E Location: Bury St. Edmunds

PART A: SUMMARY OF INFORMATION REPORTED TO UKAB

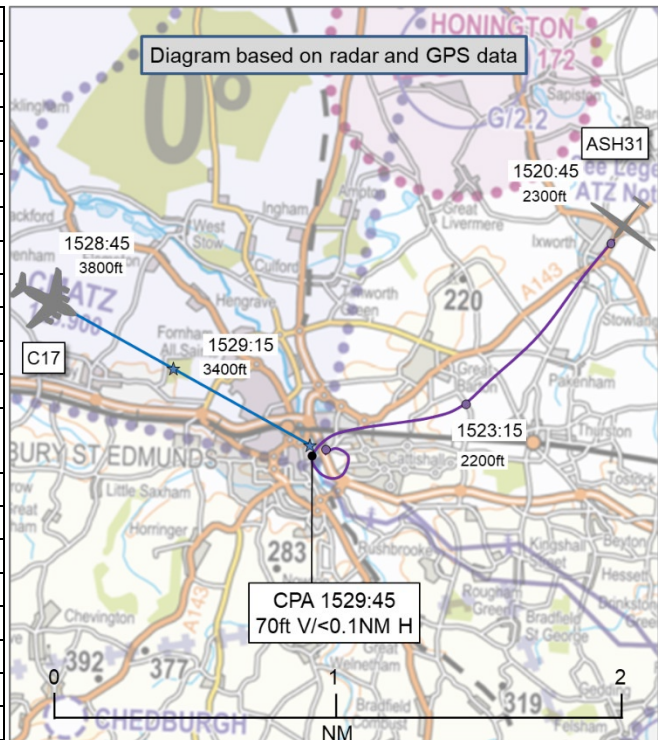
Recorded	Aircraft 1	Aircraft 2
Aircraft	C17	ASH31
Operator	HQ Air (Ops)	Civ Gld
Airspace	London FIR	London FIR
Class	G	G
Rules	IFR	VFR
Service	Traffic	None
Provider	Lakenheath App	N/A
Altitude/FL	3270ft	3340ft
Transponder	A, C, S+	Off
Reported		
Colours	Grey	White
Lighting	Anti-coll, strobes, landing	None
Conditions	VMC	VMC
Visibility	>10km	>10km
Altitude/FL	3000ft	3300ft
Altimeter	QNH (1020hPa)	QFE
Heading	110°	Circling
Speed	220kt	55kt
ACAS/TAS	TCAS II	FLARM
Alert	None	Information
Separation at CPA		
Reported	0ft V/500ft H	0ft V/20m H
Recorded	70ft V/<0.1NM H
