AIRPROX REPORT No 2024230

Date: 31 Aug 2024 Time: 0949Z Position: 5153N 00212W Location: Gloucester Airport

PART A: SUMMARY OF INFORMATION REPORTED TO UKAB

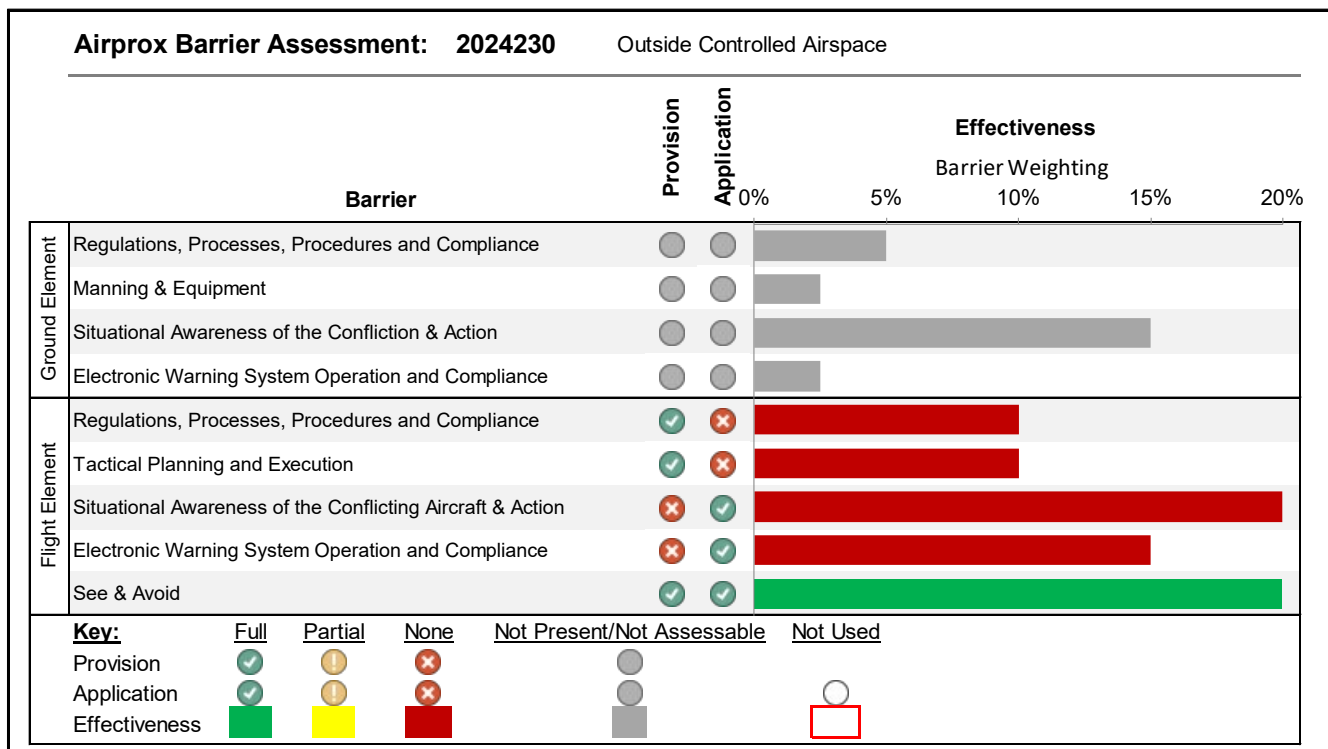
Safety Barrier Assessment³

Situational Awareness of the Conflicting Aircraft and Action were assessed as **ineffective** because neither pilot had any situational awareness of the presence of the other aircraft.

Electronic Warning System Operation and Compliance were assessed as **ineffective** because the TAS carried by the PA46 did not receive any electronic emissions from the PA28.
