**AIRPROX REPORT No 2024232**

Date: 12 Sep 2024 Time: 1256Z Position: 5301N 00029W Location: RAF Cranwell

**PART A: SUMMARY OF INFORMATION REPORTED TO UKAB**

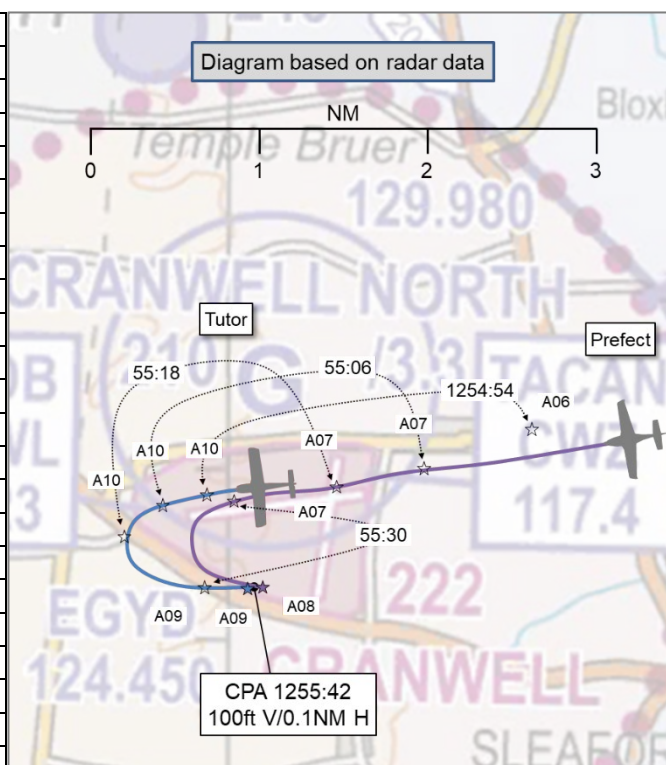
| Recorded | Aircraft 1 | Aircraft 2 |
|---|---|---|
| Reported | Not sighted | 100ft V / 1/8NM H |
| Recorded | 100ft V/0.1NM H | |

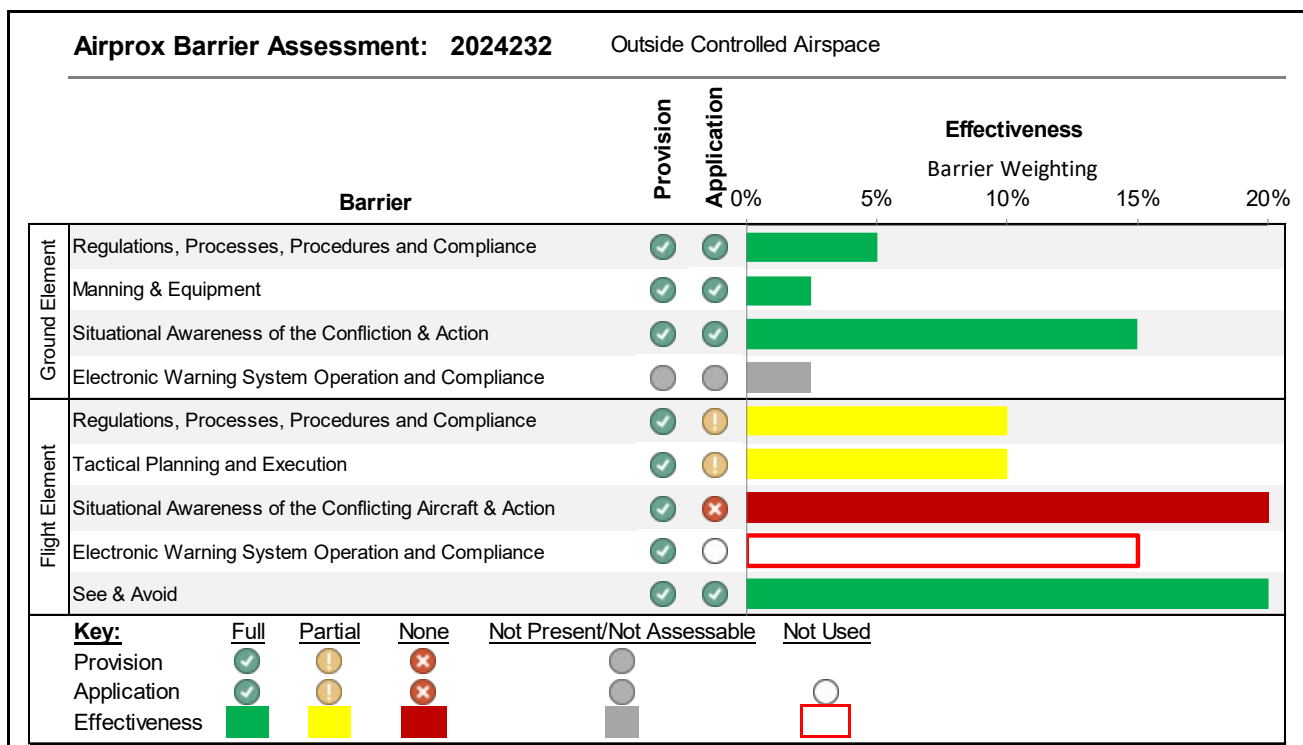
**Electronic Warning System Operation and Compliance** were assessed as **not used** because although TAS alerts were received, the proximity of the aircraft were such that the Tutor pilot had visually avoided the Prefect and the Prefect pilot had focused on flying the VRIAB manoeuvre.
