AIRPROX REPORT No 2024233

Date: 13 Sep 2024 Time:1351Z Position: 5626N 00321W Location: Perth Airport

PART A: SUMMARY OF INFORMATION REPORTED TO UKAB

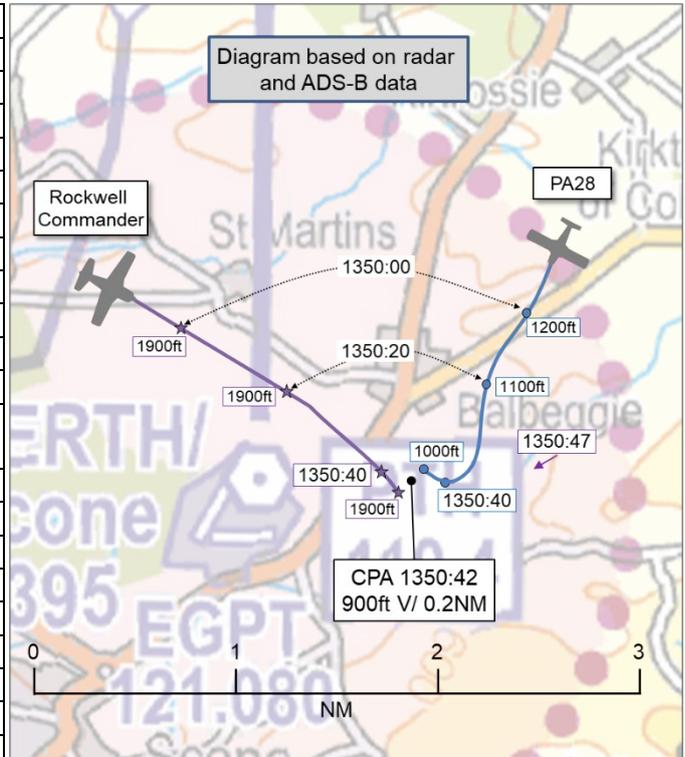
Recorded	Aircraft 1	Aircraft 2
Aircraft	PA28	Rockwell Commander
Operator	Civ FW	Civ FW
Airspace	Perth ATZ	Perth ATZ
Class	G	G
Rules	VFR	VFR
Service	AGCS	AGCS
Provider	Perth Radio	Perth Radio
Altitude/FL	1000ft	1900ft
Transponder	A, C, S	A, C, S+
Reported		
Colours	Blue/white	White/grey
Lighting	Nav, strobes and landing.	Landing and strobes.
Conditions	VMC	VMC
Visibility	>10km	>10km
Altitude/FL	2200ft	NK
Altimeter	QNH (1025hPa)	QNH
Heading	250°	210°
Speed	95kt	80kt
ACAS/TAS	Not fitted	PilotAware
Alert	N/A	None
Separation at CPA		
Reported	200ft V/0.5NM H	Not seen
Recorded	900ft V/0.2NM H
