AIRPROX REPORT No 2024248

Date: 29 Sep 2024 Time: 1234Z Position: 5627N 00314W Location: 7NM W Dundee

PART A: SUMMARY OF INFORMATION REPORTED TO UKAB

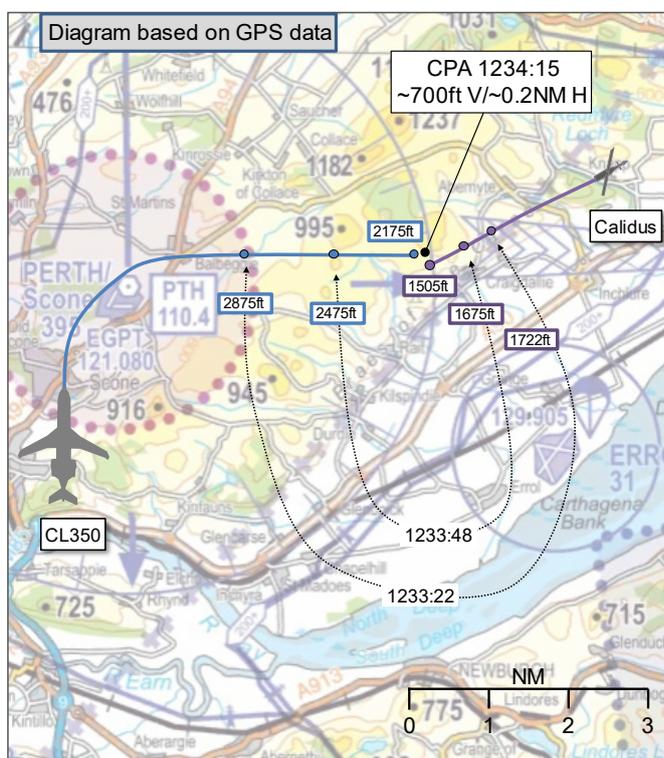
Recorded	Aircraft 1	Aircraft 2
Aircraft	CL350	Calidus
Operator	Civ Comm	Civ Helo
Airspace	Scottish FIR	Scottish FIR
Class	G	G
Rules	IFR	VFR
Service	Procedural	None
Provider	Dundee Tower	N/A
Altitude/FL	~2175ft	~1500ft
Transponder	A, C, S+	A, C, S
Reported		
Colours	Grey	Red
Lighting	'Standard'	'Yes'
Conditions	IMC	VMC
Visibility	5-10km	5-10km
Altitude/FL	2900ft	1500ft
Altimeter	QNH	QNH (1019hPa)
Heading	092°	210°
Speed	180kt	70kt
ACAS/TAS	TCAS II	SkyEcho
Alert	TA	None
Separation at CPA		
Reported	Not Seen	1000ft V/300m H
Recorded	~700ft/0.2NM

The Challenger CL350 was carrying out an RNP Approach procedure to RW09 at Dundee. Once the pilot reported passing the Final Approach Fix, ATC cleared the aircraft to land. After this point the controller attempted to establish visual contact with the aircraft and while doing so observed what appeared to be a gyrocopter approaching the RW09 extended centreline from the north. The aircraft appeared to be at an altitude of 1000-1500ft and approximately 4-5 miles to the west of Dundee. The controller began to pass Traffic Information on the gyrocopter to the CL350 pilot, but at that point the aircraft broke cloud and [the pilot] initiated a go-around. The gyrocopter was not in RT communication with Dundee ATC at the time, and it was understood that the pilot established RT communication with Perth A/G shortly after this incident. After commencing the go-around, [CL350 C/S] commenced another RNP approach to RW09 and landed with no further issues. After landing, the controller asked if the crew received any TCAS alerts and they stated that the aircraft was evident on their TCAS display but was not showing any altitude information and therefore the crew elected to commence a go-around as they were in cloud and at that point were unsure of the other aircraft's altitude. The Dundee controller estimated that the separation between the two aircraft at its closest point was approximately 400-600ft vertically and nil lateral separation.
