AIRPROX REPORT No 2023190

Date: 22 Aug 2023 Time: 1242Z Position: 5108N 00216W Location: 4NM Southwest Warminster

PART A: SUMMARY OF INFORMATION REPORTED TO UKAB

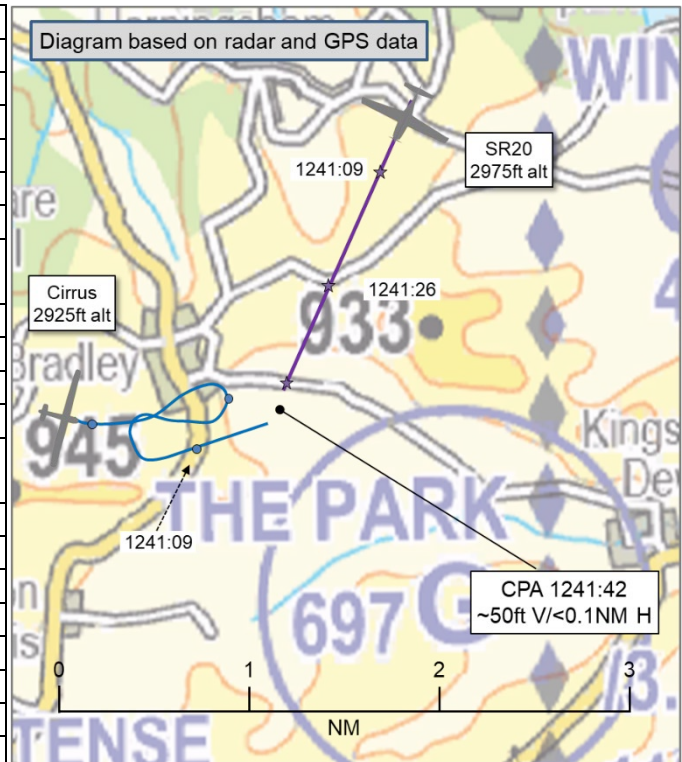
Recorded	Aircraft 1	Aircraft 2
Aircraft	Cirrus	SR20
Operator	Civ Gld	Civ FW
Airspace	London FIR	London FIR
Class	G	G
Rules	VFR	VFR
Service	Listening Out	Listening Out
Provider	Bath, Wilts and North Dorset GC	Bournemouth Rdr
Altitude/FL	2925ft	2975ft
Transponder	Not fitted	A, C, S
Reported		
Colours	White/Orange	Grey/Silver
Lighting	Not fitted	Strobes, Landing, Navigation
Conditions	VMC	VMC
Visibility	>10km	>10km
Altitude/FL	2300ft	3200ft
Altimeter	QFE (994hPa)	QNH
Heading	063°	206°
Speed	62kt	126kt
ACAS/TAS	FLARM	TAS
Alert	None	None
Separation at CPA		
Reported	100ft V/200-300m H	100ft V/0.5NM H
Recorded	~50ft V/<0.1NM H

THE CIRRUS PILOT reports that they had been flying straight and level, exploring a line of weak lift on an east-northeast heading [at approximately] 2200ft QFE (set to The Park) above Little Knoll Hill (approximately 1km southeast of Maiden Bradley) when they had noticed two white strobe lights at their 11 o'clock position at approximately the same height. [They had] then noticed something dark between those lights that had not changed position in their canopy, i.e. [they had judged that] it had been heading straight for them. Upon realising this, the Cirrus pilot immediately pushed their stick forward and altered heading slightly to the right but had kept the other aircraft visual. The pilot also reports having waved their wing tips to get themselves noticed, but the other aircraft had maintained its speed and heading with no apparent averting action being taken, which had suggested to the Cirrus pilot that they had not seen them at all. A few seconds later the aircraft had passed them on their aft portside (west-southwest of their position) by then maybe 100ft above and probably no further than 200-300m horizontally. The Cirrus pilot immediately called the launch point controller at The Park gliding club to inform them of the incident and had asked them to track the aircraft in order to obtain its details.
