## **AIRPROX REPORT No 2023208**

Date: 06 Sep 2023 Time: 1420Z Position: 5249N 00334W Location: 6NM S Bala

## PART A: SUMMARY OF INFORMATION REPORTED TO UKAB

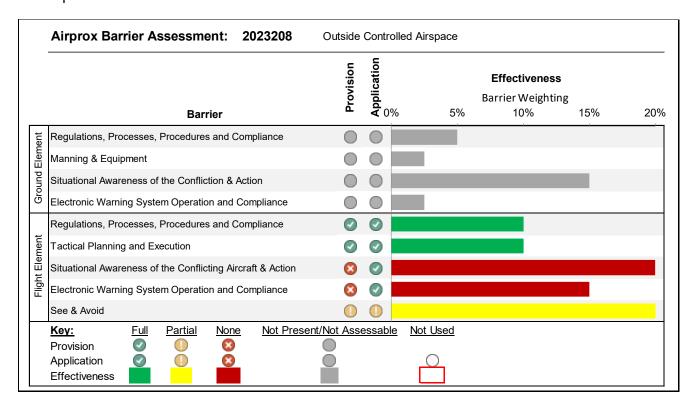
**Electronic Warning System Operation and Compliance** were assessed as **ineffective** because the EC device fitted to the ASH26 would have been expected to have detected the presence of the untraced aircraft, but no alert was reported.

**See and Avoid** were assessed as **partially effective** because the pilot of the ASH26 had visually acquired the untraced aircraft late.
