AIRPROX REPORT No 2023213

Date: 09 Sep 2023 Time: 1519Z Position: 5158N 00038W Location: 3NM N Leighton Buzzard

PART A: SUMMARY OF INFORMATION REPORTED TO UKAB

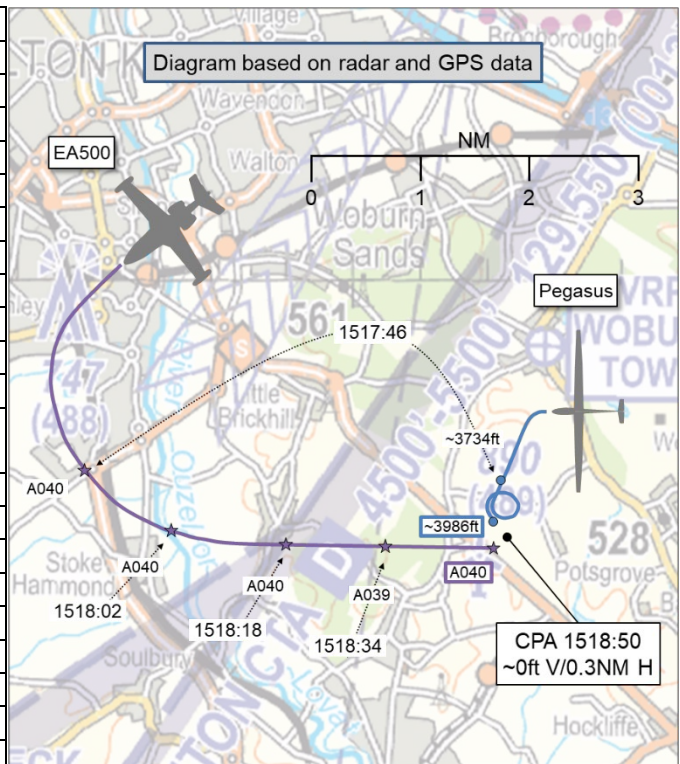
An analysis of the NATS radar replay was undertaken and the EA500 could be positively identified from Mode S data (see Figure 1). The pilot of the Pegasus kindly supplied GPS track data for their flight. Several sporadic primary-only returns were observed in the vicinity of the EA500 at the time of the Airprox. These primary-only radar returns broadly aligned with the GPS track of the Pegasus, but the identity of the aircraft could not be verified.
