AIRPROX REPORT No 2023234

Date: 03 Oct 2023 Time: 1439Z Position: 5057N 00051W Location: 7NM northwest Goodwood

PART A: SUMMARY OF INFORMATION REPORTED TO UKAB

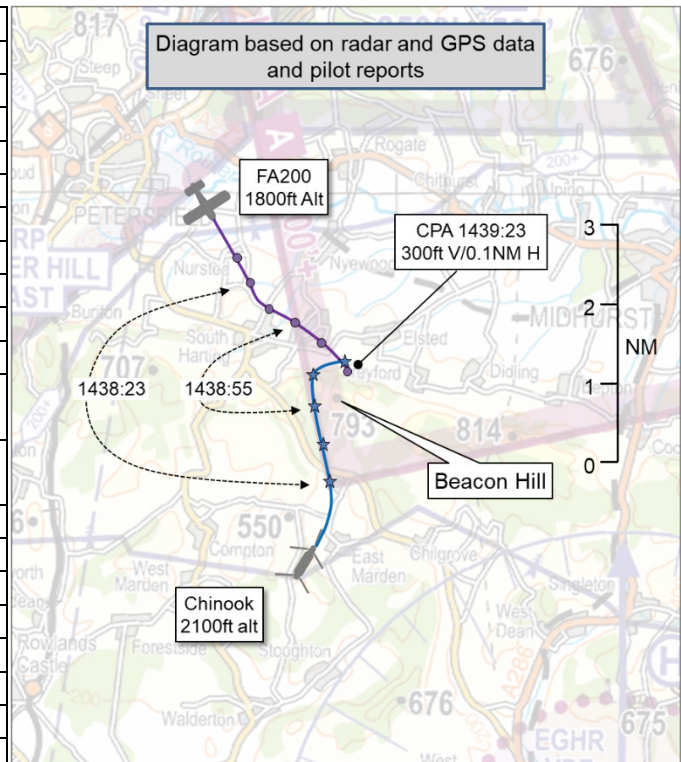
Recorded	Aircraft 1	Aircraft 2
Aircraft	Chinook	FA200
Operator	HQ JHC	Civ FW
Airspace	London FIR	London FIR
Class	G	G
Rules	VFR	VFR
Service	Basic	None
Provider	Odiham Approach	NA
Altitude/FL	2100ft	1800ft
Transponder	A, C, S	None
Reported		
Colours	Camouflage Green	Blue and white
Lighting	Strobes, navigation, landing	None
Conditions	VMC	VMC
Visibility	>10km	>10km
Altitude/FL	2000ft	NK
Altimeter	QNH (1021hPa)	QNH (1021hPa)
Heading	Turning right	NK
Speed	70kt	NK
ACAS/TAS	TAS	SkyEcho
Alert	None	None
Separation at CPA		
Reported	100-200ft V/0m H	NR
Recorded	300ft V/0.1NM H

THE CHINOOK PILOT reports that their aircraft had been set up for an 80kt/2000ft mutual support profile using Beacon Hill as the simulated landing site. The aircraft had been in a gentle right turn when the RH seat pilot saw an aircraft through the chin window approximately 100ft-200ft below. No avoiding action had been necessary. TAS had no indications. Odiham approach had no radar returns.

At about 1438, whilst heading 150° and with 10NM to run to Goodwood, the pilot spotted traffic as a black dot against the sky just above the horizon and at a relative bearing of about 045° and at a range of 2-3NM. As it stayed at a constant bearing the pilot turned 10-15° left to change the angle. Having done this the target had also turned, slightly to the right, which meant it had still been on a constant [bearing]. As it had been closer, the pilot could identify it as a Chinook and at this point had assumed the crew had seen them. The pilot kept the Chinook visible at all times as it eventually passed overhead,

slightly behind, and thought that it had been commencing a right turn. The FA200 pilot had not regarded the Chinook as a collision threat as they had been convinced that the crew had seen them.
