AIRPROX REPORT No 2023238

Date: 17 Oct 2023 Time: 1011Z Position: 5154N 00209W Location: Gloucestershire Airport ATZ

PART A: SUMMARY OF INFORMATION REPORTED TO UKAB

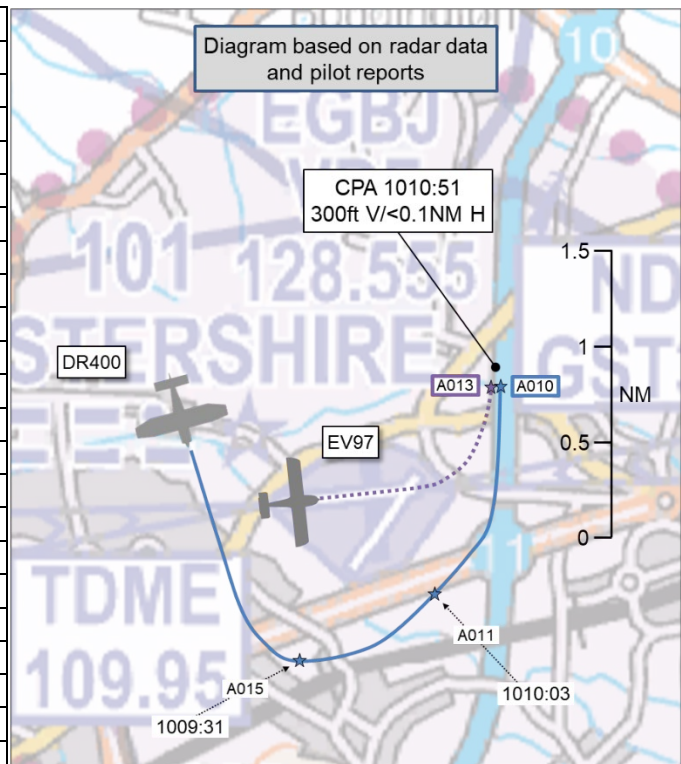
Recorded	Aircraft 1	Aircraft 2
Aircraft	DR400	EV97
Operator	Civ FW	Civ FW
Airspace	Gloster ATZ	Gloster ATZ
Class	G	G
Rules	VFR	VFR
Service	ACS	ACS
Provider	Gloster Tower	Gloster Tower
Altitude/FL	1000ft	1300ft
Transponder	A, C, S	A, C, S
Reported		
Colours	White, green	Grey, blue
Lighting	Beacon	None
Conditions	VMC	VMC
Visibility	>10km	>10km
Altitude/FL	1000ft	"in the climb"
Altimeter	QFE (1012hPa)	QFE (1012hPa)
Heading	010°	090°
Speed	90kt	80kt
ACAS/TAS	PilotAware	Not fitted
Alert	None	N/A
Separation at CPA		
Reported	0ft V/30m H	100ft V/300m H
Recorded	300ft V/<0.1NM H

THE DR400 PILOT reports that, while descending on the deadside to RW09LH pattern, the RT was very busy and they could not report descending deadside until 1200ft. They were still on the deadside at that time. Tower informed them to report downwind and Traffic Information was a Eurostar upwind. They cannot recall if it was to be in the circuit or leaving. They instructed their student to remain just between the 27 threshold and the motorway. Their relative position was just about at the aerodrome perimeter and to the west of the M5 motorway. They were level at 1000ft on QFE 1012hPa just before the live-side. Allowing for drift of 10°, they were heading 010° and about halfway along the crosswind leg (1/2NM from RW09 centreline) [when] an EV97 was sighted in their 9 o'clock position. This aircraft was at their level and climbing on a converging heading of about 040-050°. Once seen, they took control of their aircraft from the student and carried out a steep, slight descending turn to the right to ensure separation. They assumed the helicopter circuit was active, so did not descend below 900ft to avoid encroaching the helicopter circuit of 750ft. They returned the aircraft to 1000ft once clear and continued onto the downwind leg. They then handed control back to the student. The EV97 continued to climb away to the north of the aerodrome.

[The pilot of the DR400 commented that] ATC had informed them that the EV97 was 'upwind' hence they were looking to their starboard side and the aircraft was on their port side.

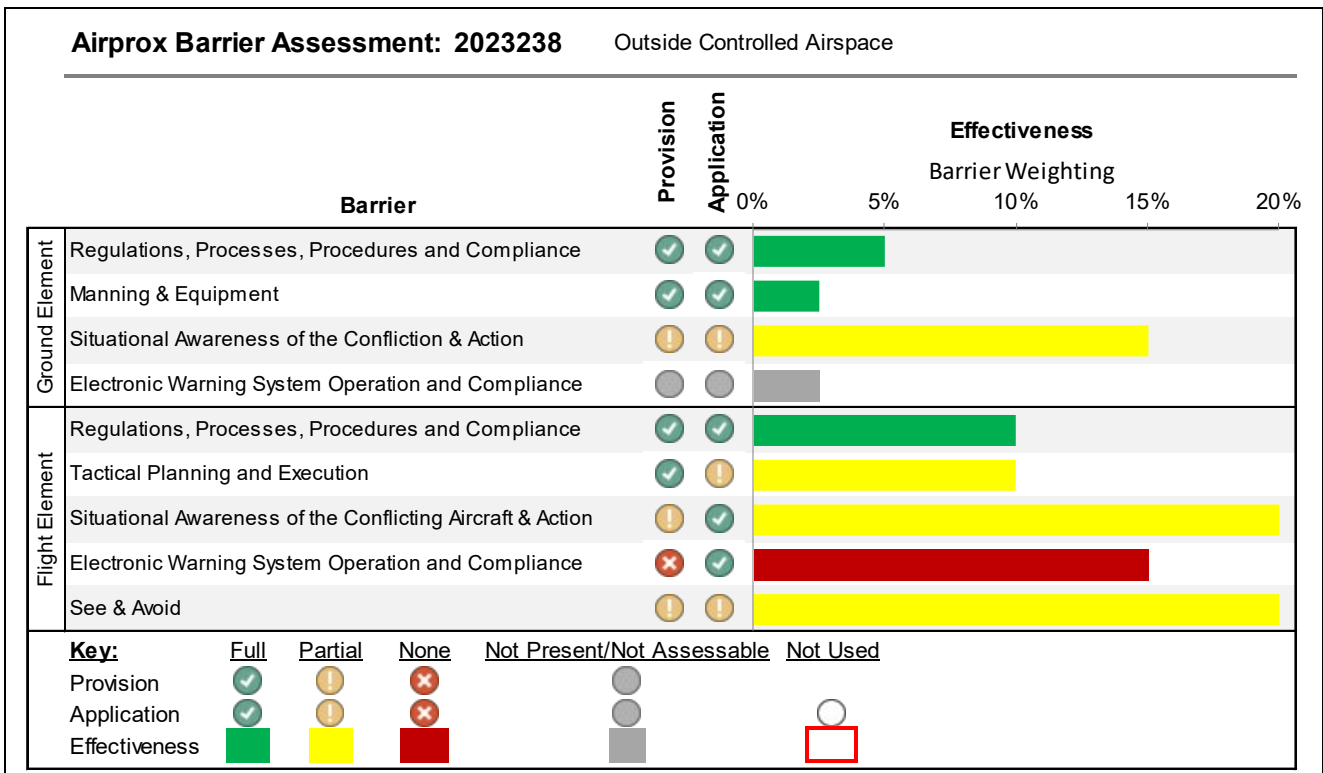
Electronic Warning System Operation and Compliance were assessed as **ineffective** because the EC device fitted to the DR400 would not have been expected to have detected the presence of the EV97.

See and Avoid were assessed as **partially effective** because the pilot of the DR400 had not visually acquired the EV97 until the moment of CPA.
