**AIRPROX REPORT No 2024017**

Date: 27 Jan 2024 Time: 1324Z Position: 5119N 00033W Location: Fairoaks ATZ

**PART A: SUMMARY OF INFORMATION REPORTED TO UKAB**

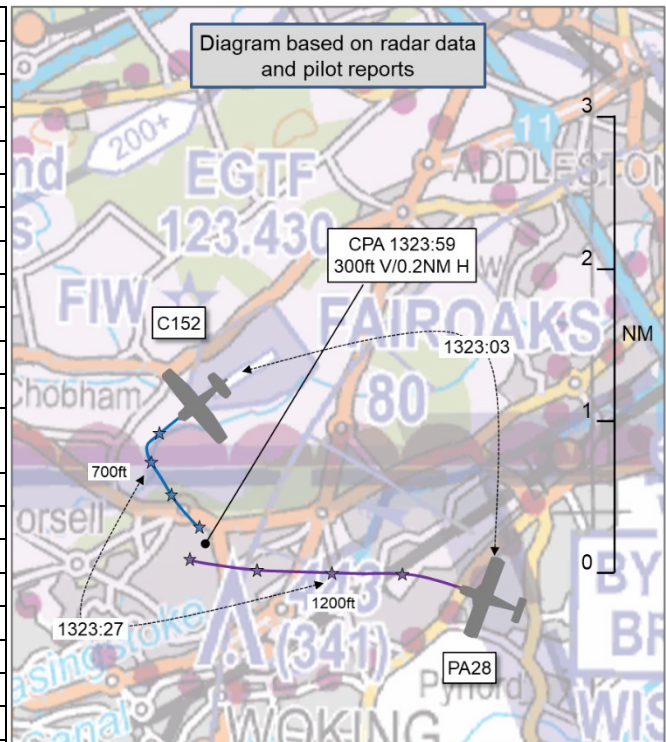
**THE C152 PILOT** reports that they had been the Instructor on a training flight to complete a circuit session at Fairoaks on RW24LH. Everything had been standard up to the holding point of the runway. At holding point B1, the pilot had become aware of the PA28 inbound by keeping a listening watch on the radio. The PA28 had been inbound from OCK intending to join the Fairoaks circuit for touch-and-goes. The C152 student pilot then completed take-off and climb-out as standard. At a point between take-off and crosswind, the Instructor had heard the PA28 pilot reporting that they would be completing a downwind join. Following this, the Instructor had ensured a good lookout until the aircraft had been visual. Information was passed to the PA28 pilot from Fairoaks Radio regarding the C152 on climb-out and the intention to stay in the circuit. On crosswind at approximately 800ft in the climb, the PA28 had been observed through the front cockpit windshield, flying from left-to-right at what the Instructor estimated to be the circuit altitude of 1100ft and on the reciprocal of the downwind track. Both aircraft had been converging at the turning point of crosswind to downwind. The Instructor took control of the aircraft from the student in order to ensure that a dangerous loss of separation would not occur. At this point the following radio transmissions occurred: Fairoaks Radio: 'Fairoaks [C152 c/s] are you visual with the traffic'? Fairoaks [C152 c/s]: 'Affirm visual they appear to be flying the wrong way down downwind'. The PA28 pilot [transmitted] 'I'm not flying the wrong way down downwind, I'm doing a downwind join [redacted]'. In order to maintain separation, the C152 Instructor altered course to the left to pass behind the PA28. Soon after that, the C152 Instructor simultaneously levelled off at circuit altitude and made the turn to downwind. With the aircraft now straight and level they passed control back to the student and focused on regaining visual with the PA28 after they had passed behind. The student reported downwind as standard. The Instructor had then become visual with the PA28 who had been in the 7 o'clock position. This had put them off the port wing within the C152 circuit at the same level. It appeared that the PA28 pilot had completed a 180° turn behind the C152 to establish themselves on a tight downwind next to the C152. The C152 Instructor advised the student of the location of the traffic but instructed them to maintain the same track and continue with a normal circuit. As there had been a speed difference between the aircraft, the PA28 had then been in the 8 o'clock

position by late downwind. The following radio transmissions had occurred: 'PA28 c/s this is [C152 c/s], what are your intentions as you are now off our left-hand wing in the circuit'? The PA28 pilot responded with: 'I am downwind and am going to do a tight left-hand circuit to get ahead, I thought you were leaving the circuit'. [C152 c/s] replied with 'Roger'. The PA28 pilot then completed a tighter than standard turn to base and the C152 pilot completed a standard turn onto base. The student started to set up for the approach. As they descended on base, the PA28 pilot decided to go-around to allow them to complete the approach. The following radio transmissions occurred: '[PA28 c/s] going around'; Fair Oaks Radio: 'Roger and be aware that I did give you Traffic Information on the aircraft remaining in the circuit'. The PA28 pilot responded with 'Sorry I must've missed that'. Both aircraft remained in the circuit and no further issues developed.
