**AIRPROX REPORT No 2024076**

Date: 04 May 2024 Time: 1225Z Position: 5044N 00319W Location: ivo Exeter ATZ

**PART A: SUMMARY OF INFORMATION REPORTED TO UKAB**

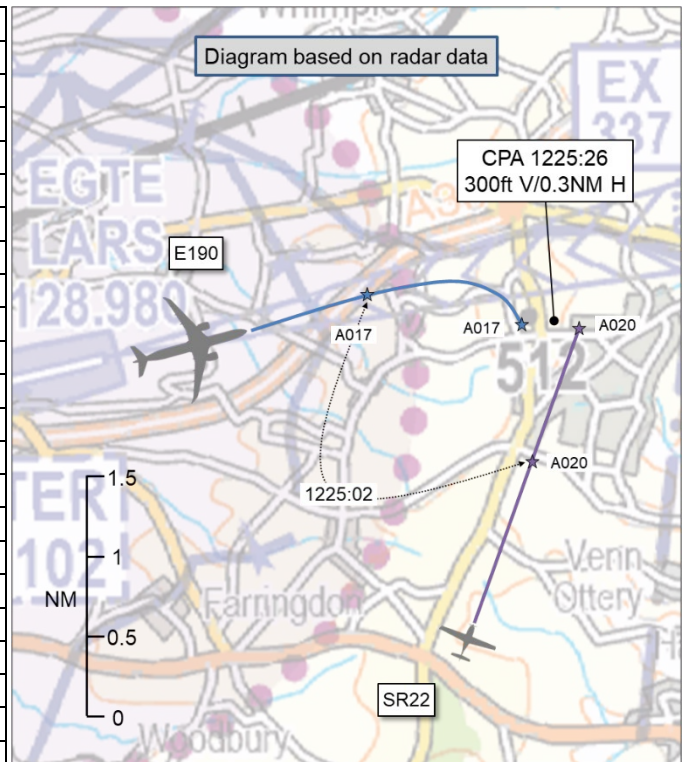
Recorded	Aircraft 1	Aircraft 2
Aircraft	E190	SR22
Operator	CAT	Civ FW
Airspace	London FIR	London FIR
Class	G	G
Rules	VFR	VFR
Service	ACS	Basic
Provider	Exeter Tower	Exeter Radar
Altitude/FL	1700ft	2000ft
Transponder	A, C, S+	A, C, S
<b>Reported</b>		
Colours	Company colours	White
Lighting	"standard"	Strobe
Conditions	VMC	VMC
Visibility	>10km	>10km
Altitude/FL	1500ft AGL	2000ft
Altimeter	QNH (1010hPa)	QNH
Heading	170°	019°
Speed	180kt	140kt
ACAS/TAS	TCAS II	TAS
Alert	RA	Information
<b>Separation at CPA</b>		
Reported	300ft V/0.5NM H	1000ft V/5NM H
Recorded	300ft V/0.3NM H

[The pilot of the] E190 received a TCAS Resolution Advisory (RA) whilst crosswind in the visual circuit due to a transiting SR22 on a converging track outside the ATZ. The distance between the two aircraft reduced to 300ft vertically, 0.4NM laterally.

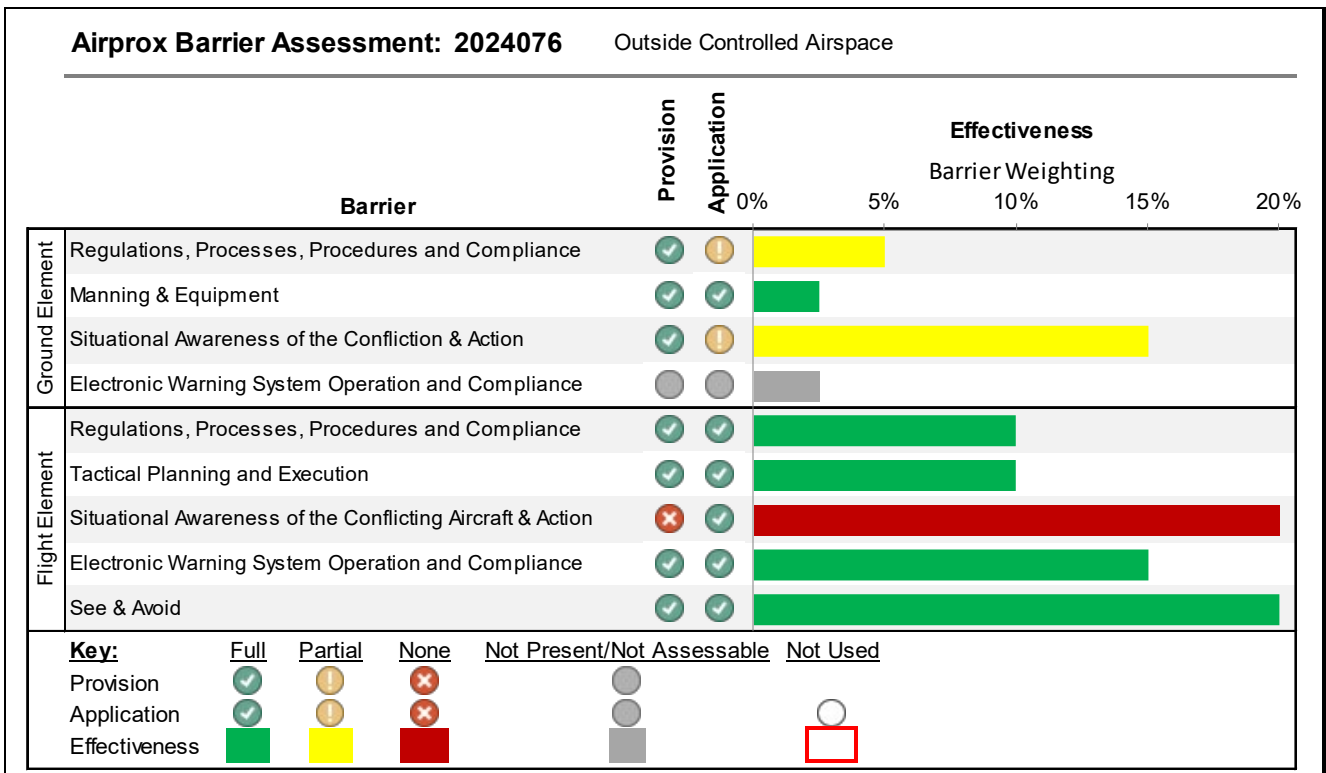
**Flight Elements:**

**Situational Awareness of the Conflicting Aircraft and Action** were assessed as **ineffective** because the pilot of the SR22 had not had situational awareness of the presence of the E190 until it had been visually acquired.
