**AIRPROX REPORT No 2024083**

Date: 07 May 2024 Time: 1535Z Position: 5113N 00113W Location: 1.4NM N of Popham

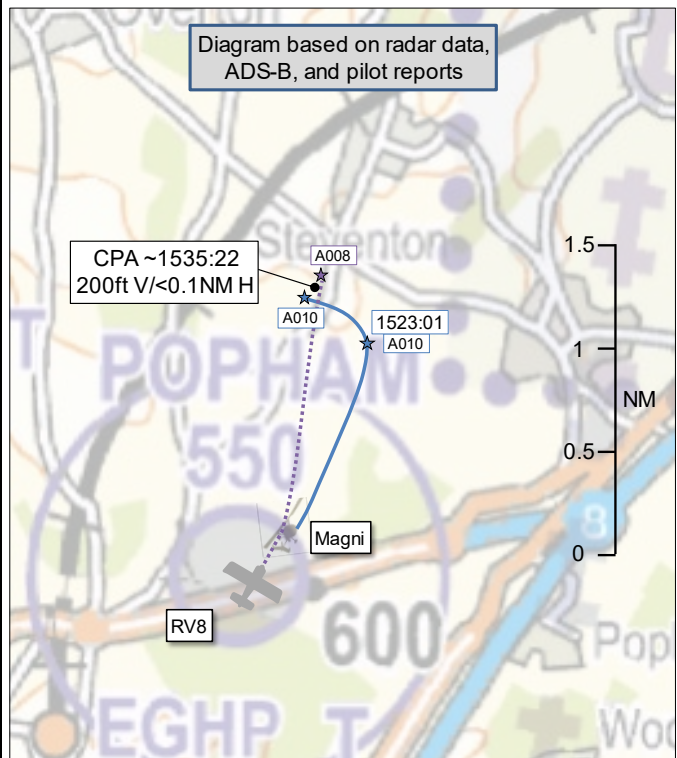
**THE MAGNI PILOT** reports they were conducting a circuit detail at Popham airfield on RW03 when a visiting RV8 landed and was heard on the radio asking to jump the queue for fuel due to a flight-plan timing limitation. A few minutes later, as they were on a tight left base, the aeroplane was observed at the 03 hold, aligned with the runway direction and with their tail towards the final approach. Just as they were about to turn on to a short final [the RV8 pilot] announced that they were lining up on RW03. The radio operator advised [the RV8 pilot] that a gyroplane (the Magni) was about to turn on to short final and that further traffic (a Bristell NG5) was about to turn on to a longer final. [The RV8 pilot remained in] position while they conducted a touch-and-go and the aircraft behind them landed. As they were just over half way along the crosswind leg at about 800ft AAL they looked to the right to check for traffic joining the downwind leg. They then saw the RV8 come into view having passed directly underneath their aircraft and not very far below it. They reported the Airprox to the radio operator at Popham; the departing RV8 pilot confirmed the Airprox on the radio.

**THE RV8 PILOT** reports that in the climb after take-off, passing approximately 1200ft, they saw the gyrocopter in their right 1 o'clock [position] crossing right-to-left approximately 300m ahead and 200ft above on a potential collision course. They levelled off to pass below it.
