AIRPROX REPORT No 2024087

Date: 10 May 2024 Time: 1249Z Position: 5212N 00014W Location: 2NM west of Abbotsley

PART A: SUMMARY OF INFORMATION REPORTED TO UKAB

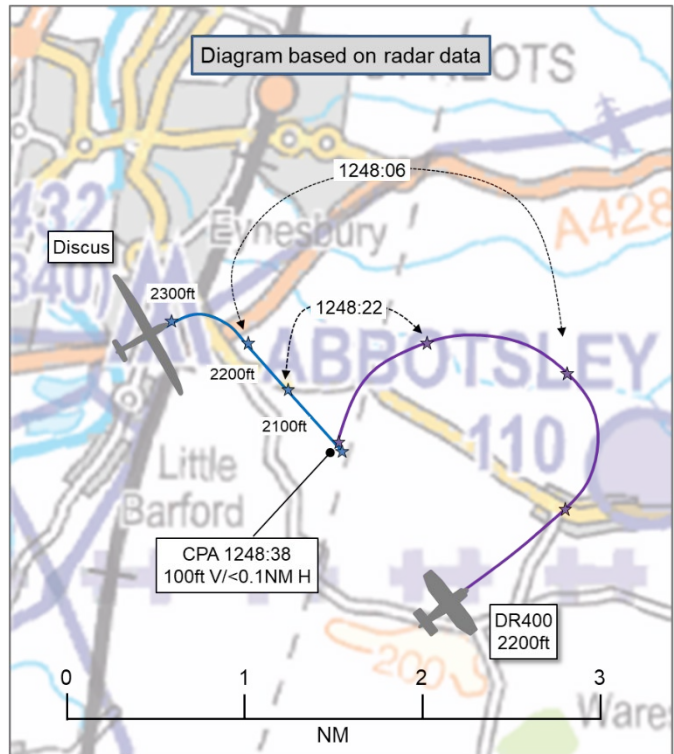
THE DISCUS PILOT reports that they were flying locally to [destination airfield], re-familiarising themselves with the aircraft after the winter lay-off. There had been a cumulus cloudbase (about 4/8) at about 4000ft. Visibility had been good but degraded at around 3000ft. The pilot reports that they had been looking for a strong-ish thermal over St Neots; the current thermal had not been strong. They had not seen any other aircraft during this part of the flight. As they had straightened up, they had seen the other aircraft ahead and to their left. It had been turning away and probably a bit lower. It looked as though it had been taking avoiding action though the turn was not sharp. The Discus pilot had maintained their course as there had been no danger of collision at that point. Later it looked as though the other aircraft had turned right to resume its original course. The Discus pilot had then returned to [destination airfield] without incident.
