AIRPROX REPORT No 2024121

Date: 25 Apr 2024 Time: 1051Z Position: 5422N 00136W Location: Catterick

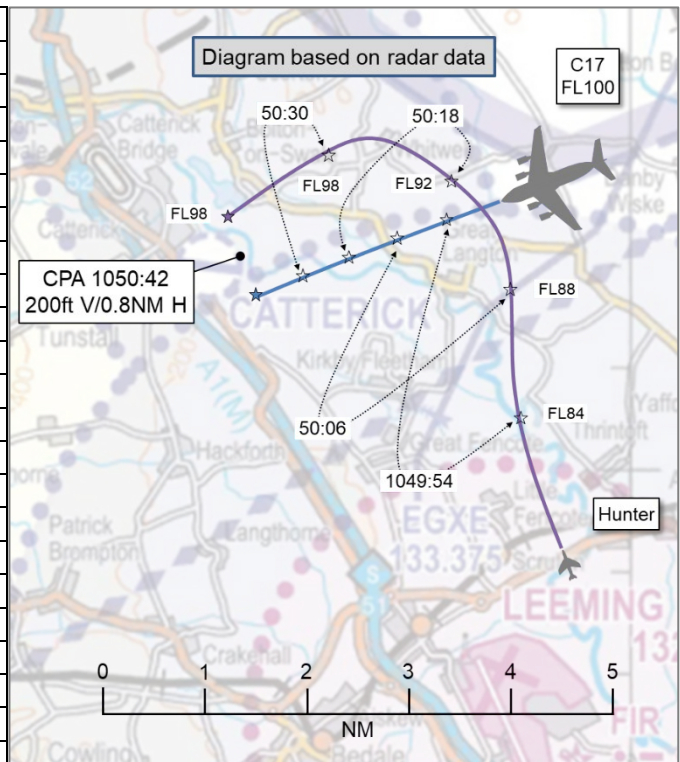
Recorded	Aircraft 1	Aircraft 2
Aircraft	C17	Hawker Hunter
Operator	HQ Air (Ops)	Civ Comm
Airspace	London FIR	London FIR
Class	G	G
Rules	VFR	VFR
Service	Traffic	Traffic
Provider	Leeming Approach	Leeming Radar
Altitude/FL	FL100	FL098
Transponder	A, C, S+	A, C, S
Reported		
Colours	Grey	Grey/green
Lighting	'all normal lights'	Strobe, nav
Conditions	VMC	NR
Visibility	>10km	NR
Altitude/FL	FL100	NR
Altimeter	SPS	NR
Heading	250°	NR
Speed	130kt	NR
ACAS/TAS	TCAS II	TAS
Alert	RA	NR
Separation at CPA		
Reported	NR V/1NM H	NR V/>1NM H
Recorded	200ft V/0.8NM H
