AIRPROX REPORT No 2024124

Date: 17 Jun 2024 Time: 1301Z Position: 5213N 00005E Location: 4NM W Cambridge

PART A: SUMMARY OF INFORMATION REPORTED TO UKAB

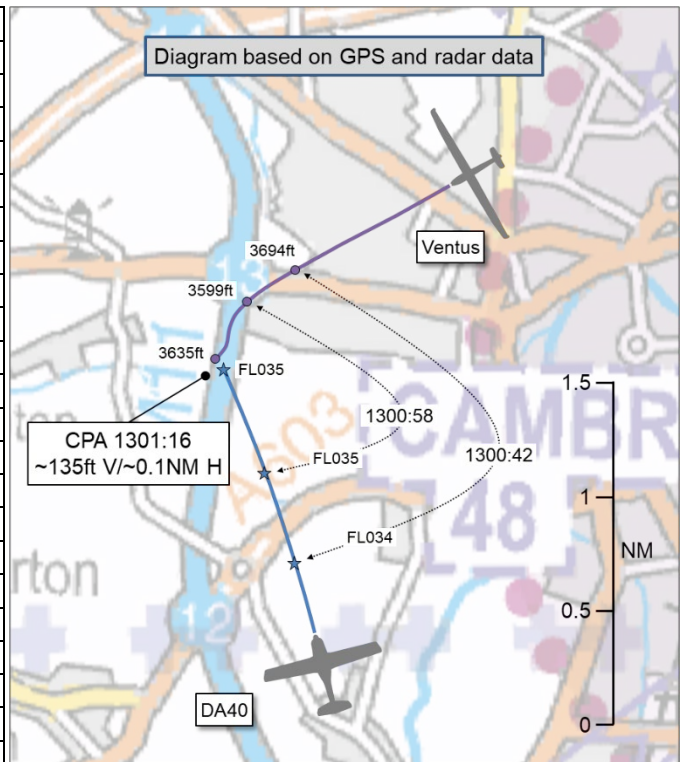
Recorded	Aircraft 1	Aircraft 2
Aircraft	DA40	Ventus
Operator	Civ FW	Civ Gld
Airspace	London FIR	London FIR
Class	G	G
Rules	IFR	VFR
Service	Traffic	Basic
Provider	Cambridge Radar	Cambridge Radar
Altitude/FL	FL035	3635ft
Transponder	A, C, S+	Not fitted
Reported		
Colours	White	White
Lighting	Strobes, Indg, nav	Canopy strobe
Conditions	VMC	VMC
Visibility	>10km	>10km
Altitude/FL	3500ft	3800ft
Altimeter	QNH	QFE
Heading	340°	"west"
Speed	110kt	70kt
ACAS/TAS	TAS, SkyEcho	FLARM
Alert	None ¹	N/A
Separation at CPA		
Reported	0ft V/30m H	100ft V/50m H
Recorded	~135ft V/~0.1NM H
